So another Quad 405 comes in for some tender care, this one is a 405-2 with series 6 circuit boards. It is very similar to the last 405 that I repaired; I just had to add R18 to the photo I had taken before.

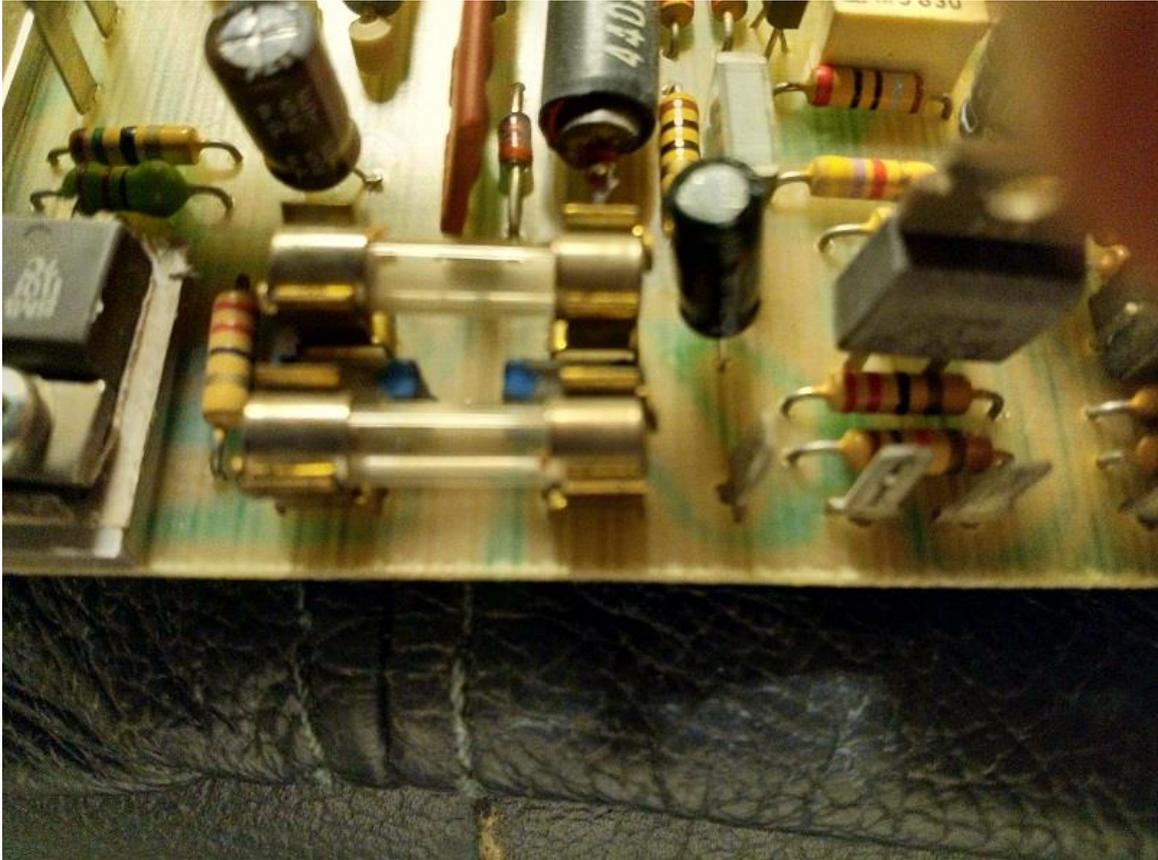
Both 4A supply fuses Blown.

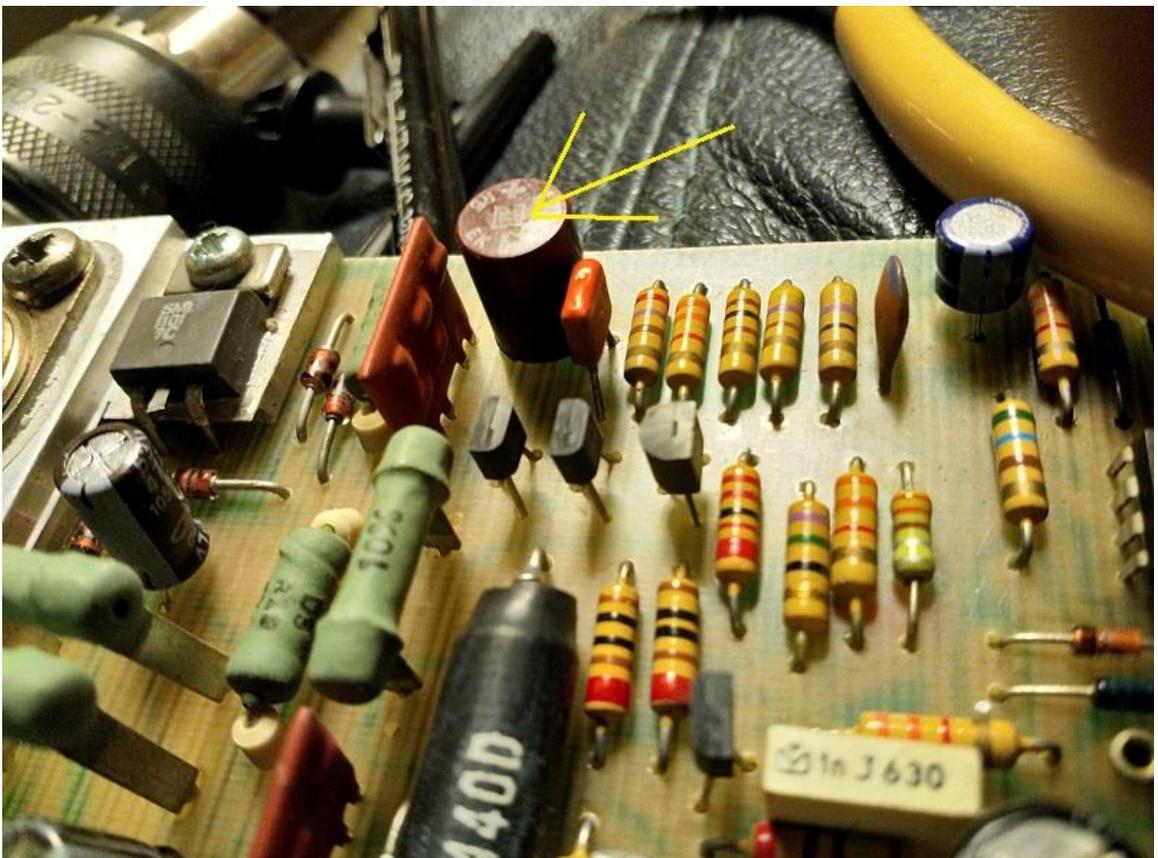
C18 case cracked

R7 3k3 was found open circuit and was probably responsible for the suspected death of all of the transistors while heat from R30 and R31 caused C10 to lose its capacitance, falling from 47uF to 11uF. C18 and C19, both 47uF, were also found to be low as also the 100uF capacitors C2 and C5.

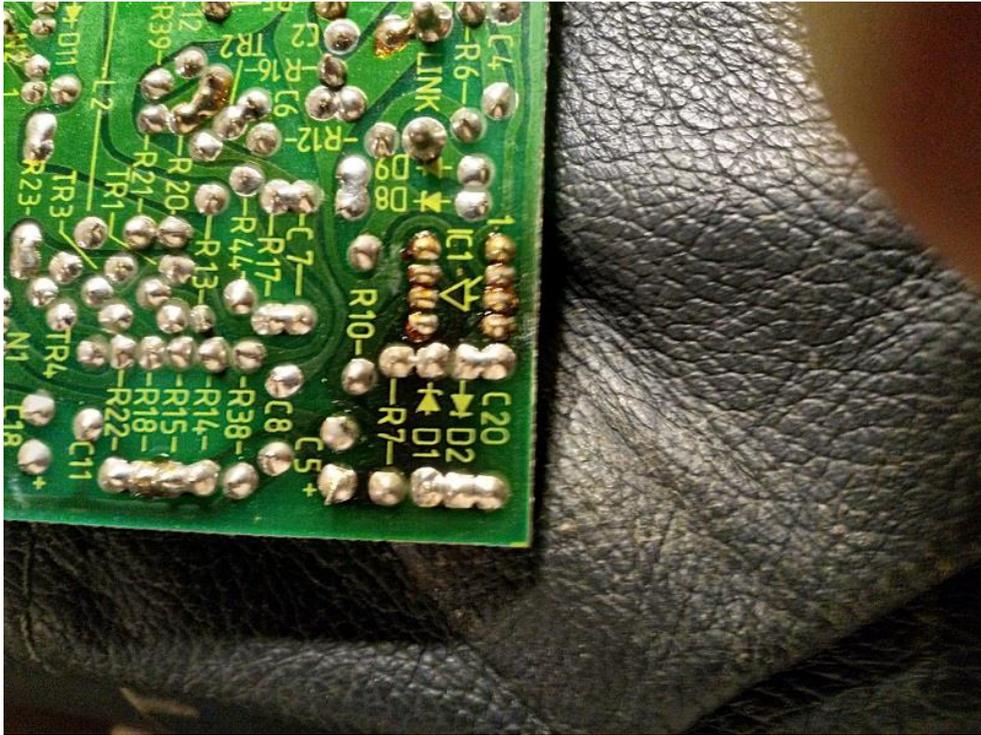
Signs of overheating around the Op-Amp IC1.

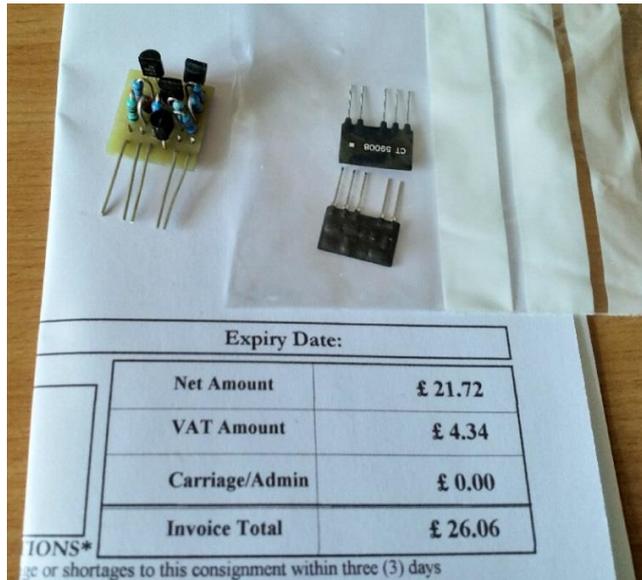
Due to space limitations, the initial design had to be reversed so that components face the rear of the board and not the front. As the trip to Quad in Huntington was fruitful in obtaining some thick films; a simple resistance check shows that one of the originals definitely has a fault.

In years to come the parts from Quad may be unavailable and this work will then perhaps be found to be useful. My home made effort measured OK though it was a nightmare to fit the fine copper wires with my shaking hands, the lower resistance associated with pin 5 is due I think to the Zener diode I used.

Test Points +/-	Home made	New 1	New 2	Old 1	Old 2
1-2	994	997	999	994	997
1-3	5.8k	5.79k	5.79k	5.82k	5.81k
1-4	inf	inf	inf	inf	96k
1-5	17 Meg	inf	35 Meg	24 Meg	25.9 Meg
2-3	4.8k	4.79k	4.8k	4.83k	4.8k
2-4	inf	inf	inf	inf	97.7k
2-5	17 Meg	inf	33.7 Meg	24.8 Meg	25.9 Meg
3-4	inf	inf	inf	inf	103.5k
3-5	17 Meg	inf	33.7 Meg	25 Meg	25.9 Meg
4-5	inf	inf	inf	inf	25.9 Meg
Test Points -/+	Home made	New 1	New 2	Old 1	Old 2
1-2	994	997	999	995	1k
1-3	5.8k	5.79k	5.79k	5.82k	5.81k
1-4	inf	inf	inf	inf	167k
1-5	inf	inf	inf	inf	inf
2-3	4.8k	4.8k	4.8k	4.83k	4.81k
2-4	inf	inf	inf	inf	168k
2-5	inf	inf	inf	inf	inf
3-4	inf	inf	inf	inf	174k
3-5	inf	inf	inf	inf	inf
4-5	inf	inf	inf	inf	inf
					SUSPECT T3 or T4

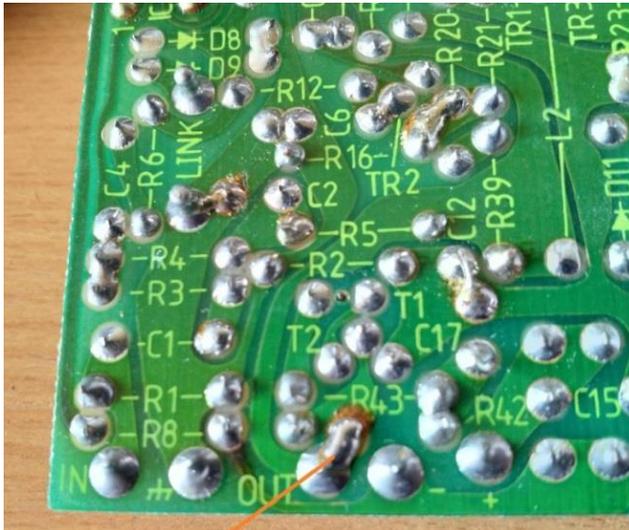
SOLDER LINK

Power supply was slowly advanced towards 6V to check that the current drawn was no greater than 0.5mA. High current however was drawn at just 1V which was a failure so the Triac was replaced, after this the circuit drew no current until the Diac conducted at around 10V which is what it should do. Circuit was checked again with reverse polarity and operated correctly.

Removed the solder link as shown below which isolated the clamp circuit from the rest of the board. A test wire was soldered to the pad as shown and a power supply (initially set to zero volts), was connected to this wire via a 100 Ohm limiting resistor and an Ammeter. The 0V of the power supply was connected to circuit Ground.

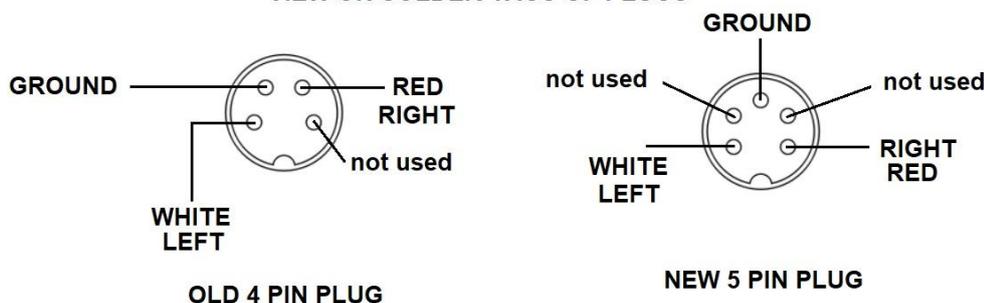
VIEW ON SOLDER TAGS OF PLUGS

The 4 Pin input DIN connector appears faulty in as much as the plug can be inserted in a number of ways. This was replaced with a new 5 Pin DIN plug and the wiring appears on upper half of page 4. This is a better quality DIN plug and socket which also has a retaining ring for security.

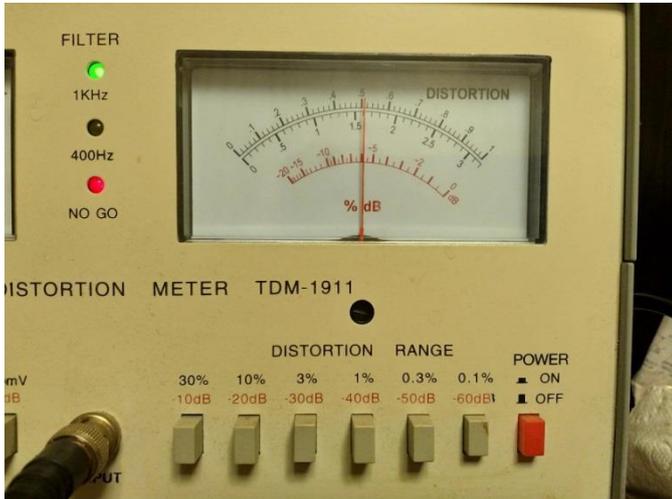
LEFT CHANNEL (Working original)

Everything looked fine, no crazy offset voltages on the outputs and they can be pushed to well over 40 Watts. I compared the distortion of the repaired channel (Right) with the good working Left channel. Both channels show 0.05% at near maximum output so I consider this to be good.
