REPAIRING
THE
RM KL400
LINEAR AMPLIFIER.

Les Carpenter G4CNH
December 2012

The following is a step by step guide to fixing your KL400 amplifier. Each part will be individually tested up to the final output stage, which should there still be no RF output, can then be considered to have probable output transistor failure. A simple test is provided that may prove a failure in one or both output transistors.

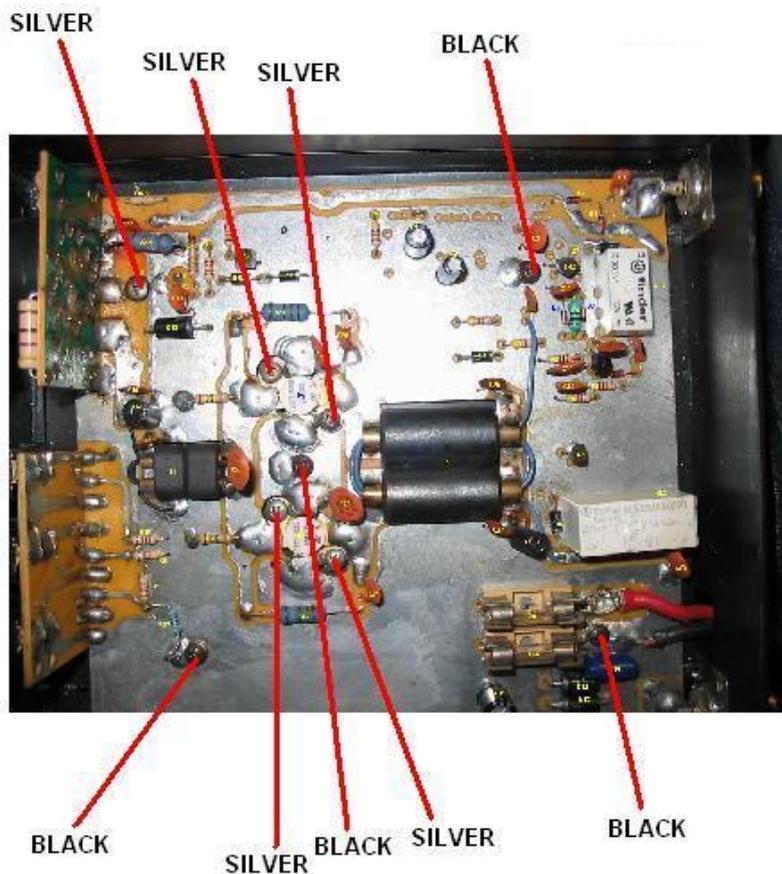
Remove two screws from each coax socket.
Remove four screws securing front panel.
Remove four Black and five Silver screws as shown below:-

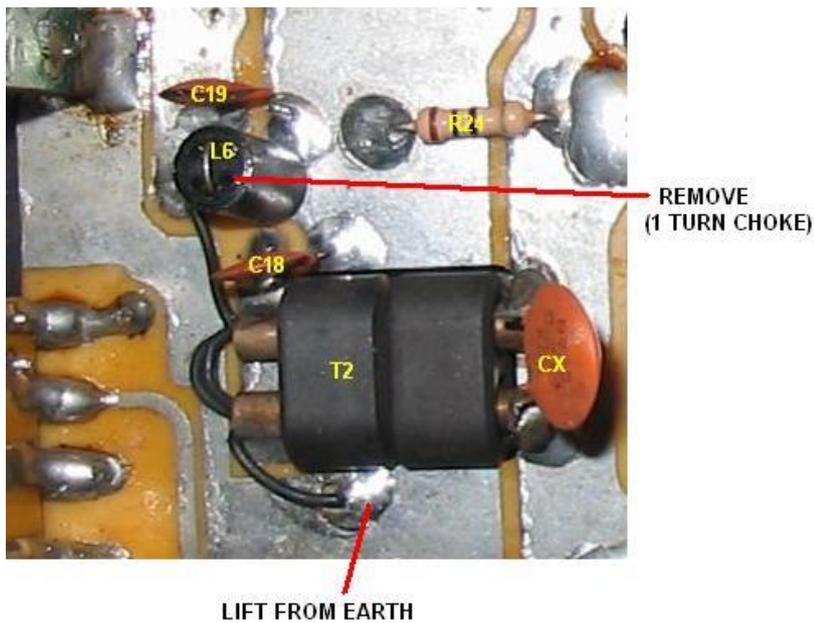
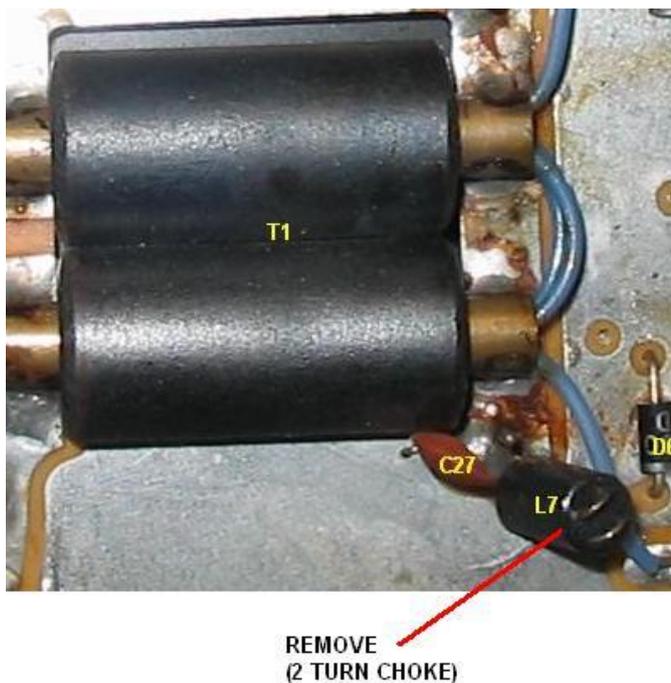
Using a soldering iron, remove L6, L7 and disconnect earthy end of T2 primary:-

Reason: Removing L6 isolates PA Bias Supply, removing L7 isolates 12V from the final transistors and removing ground wire from T2 isolates the DC control switch to allow DC testing of the Power switch board and its associated components.

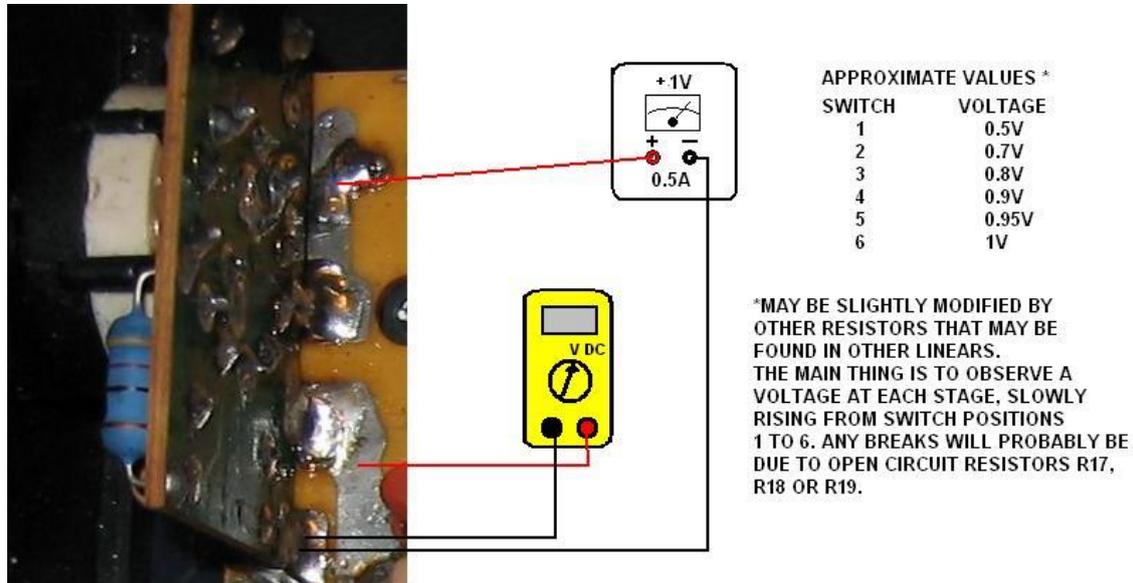
Apply 1 Volt to the power switch wiper A and monitor the output using a Multimeter and DC Test Circuit as shown below:-.

(Note a 1.5V cell can suffice but expect slightly higher voltages)

This should have proved Power Control Switch, R17, R18, R19, R20, R21 and R22.

If you found some switch positions faulty then it is highly likely that one of the attenuator resistors mounted on the switch board is faulty. A common failure is an open circuit 10 Ohm resistor R19.

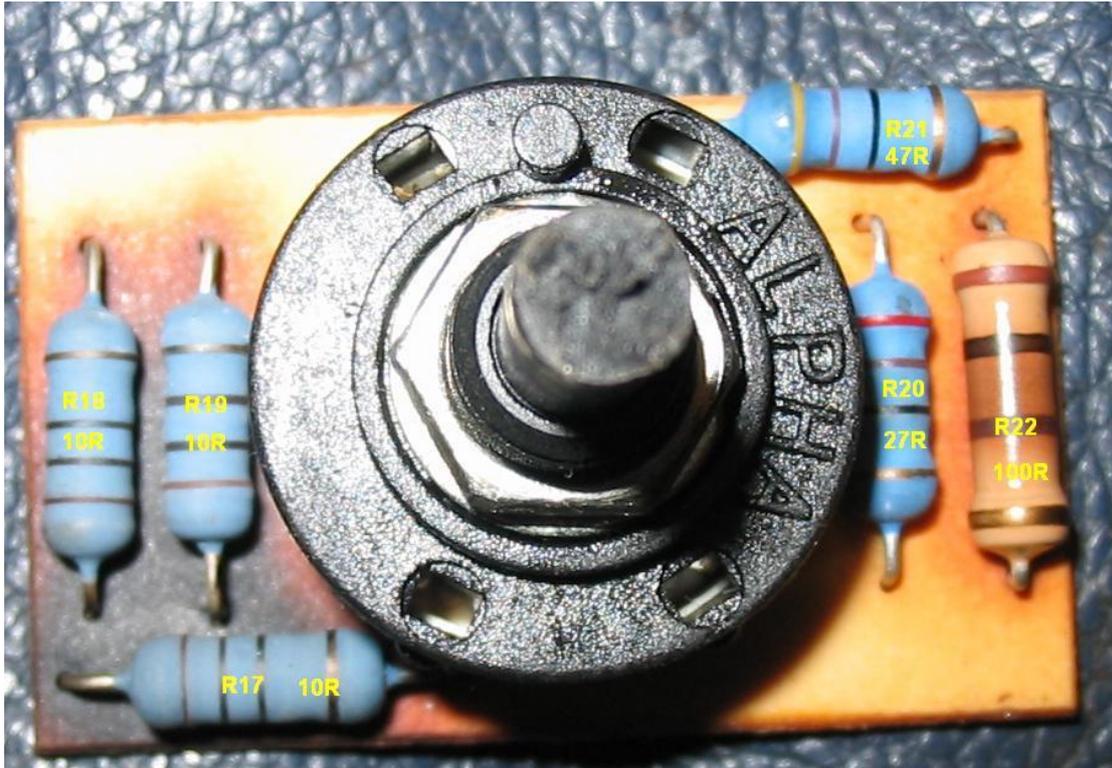
Set the switch fully anti-clockwise (Position 1) and using the Multimeter, check across each of the resistors for the values shown with no more than 5% error. Expect the 10 Ohm resistors to be between 9.5 and 10.5 Ohms, the 27 Ohm resistor to be between 25.6 and 28.3 Ohms, the 47 Ohm resistor to be between 44.6 and 49.3 Ohms and the 100 Ohm resistor between 95 and 105 Ohms. Replace as necessary.

Now if you dislodged the indent washer, simply refit to the switch with the tab on the washer located in one of the slots. Turn the switch from position 1 and count 2, 3, 4, 5, 6 before the switch rotation stops. If you have too many or too few stops, reset switch to position 1, relocate the tab on the washer to another slot and repeat until all six positions can be made. Carefully replace the switch into the front panel and secure with the nut and washers previously removed, making sure the indent washer does not fall out while you are doing it!

Now hold the two boards together at 90 degrees and reflow solder onto the three pads. Replace the knob and tighten the grub screw when the knob pointer indicates correctly on the front panel markings.

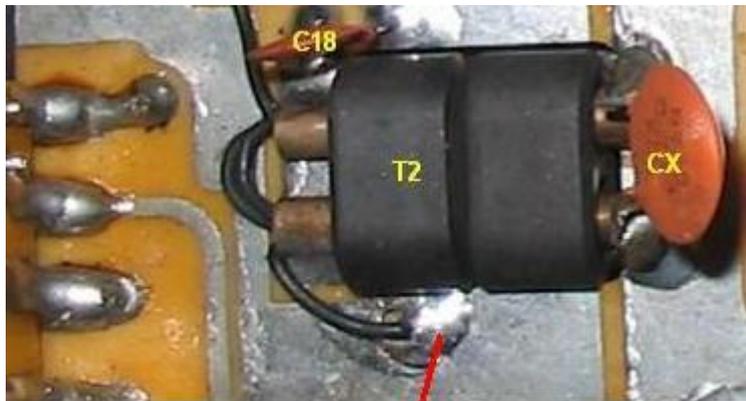
REPLACE THIS WIRE

Reconnect wire previously removed from T2 to ground plane.

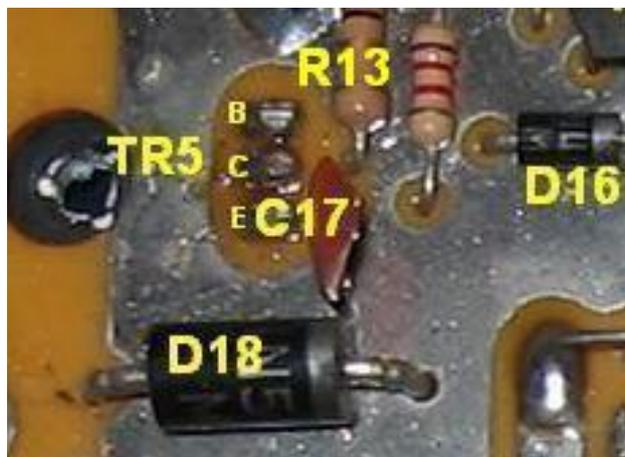
Check with a Multimeter that there is 12V available on TR5 collector (C).
(Proves R13 is not open circuit or C17 is short circuit)

R13 acts as a safety fuse resistor. If R13 is open circuit then check TR5 which probably no longer acts as a constant current source and the reason for R13 failure.

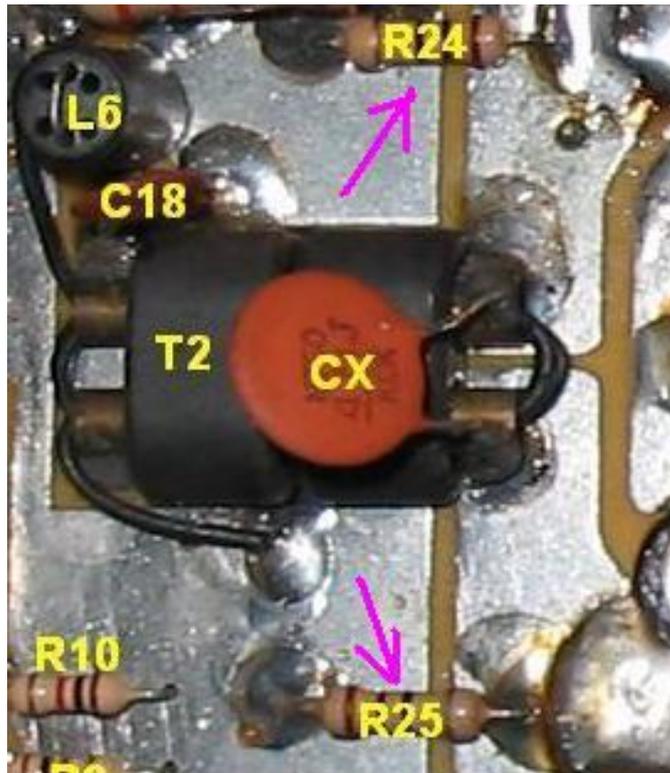
Replace L6 (1 turn choke) then by briefly keying rig, verify that the bias voltage is present across R24 and R25.

(Proves C18 not short circuit and that the circuit board track to and including T2 is not open circuit)

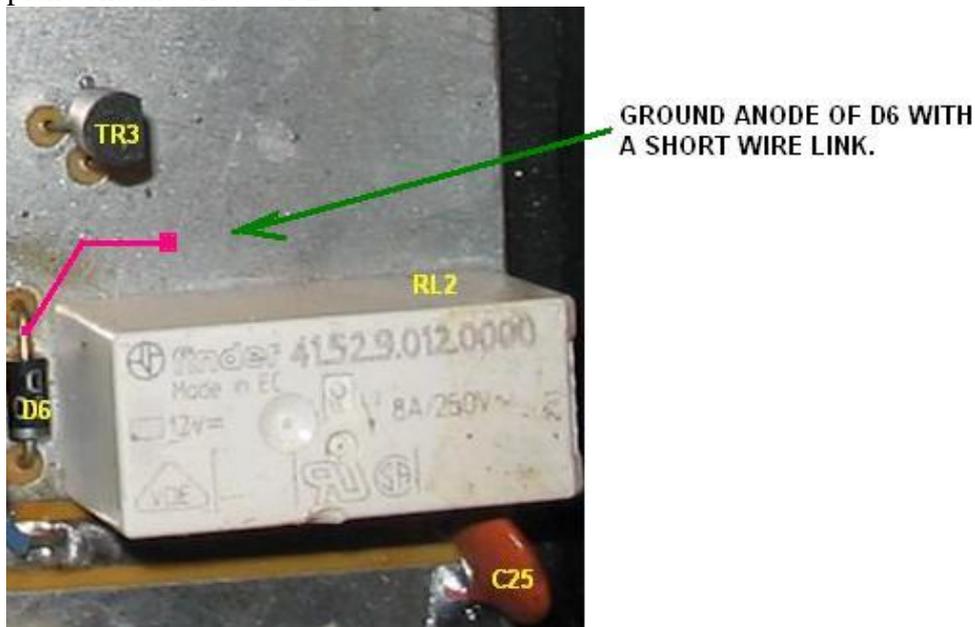
The easiest way to make RL2 operate is to apply a short link wire between the ground plane and the anode of D6.

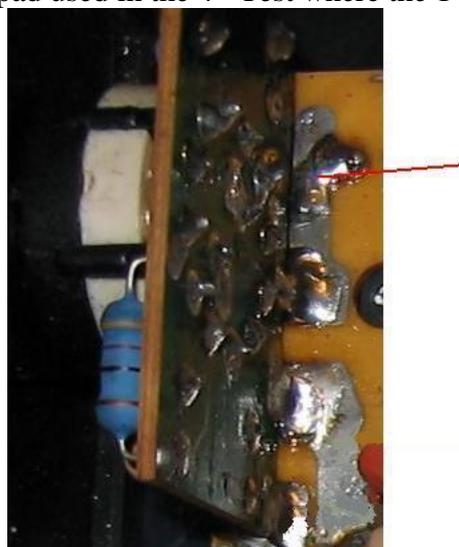
Using the Multimeter as a continuity tester, connect it between the inner of the RIG coax socket (Top right with front panel to your left) and the power control board input pad. This is the pad used in the 4th Test where the 1V test voltage was applied.

Briefly apply the 12V supply and check continuity is established then switch off the 12V supply.

(If no continuity is established, an open circuit can be caused by poor contact from one side of the main board to the other side, due to corrosion on connecting through-wires. The Multimeter will be able to detect where the disconnection is occurring and where application of fresh solder is required).

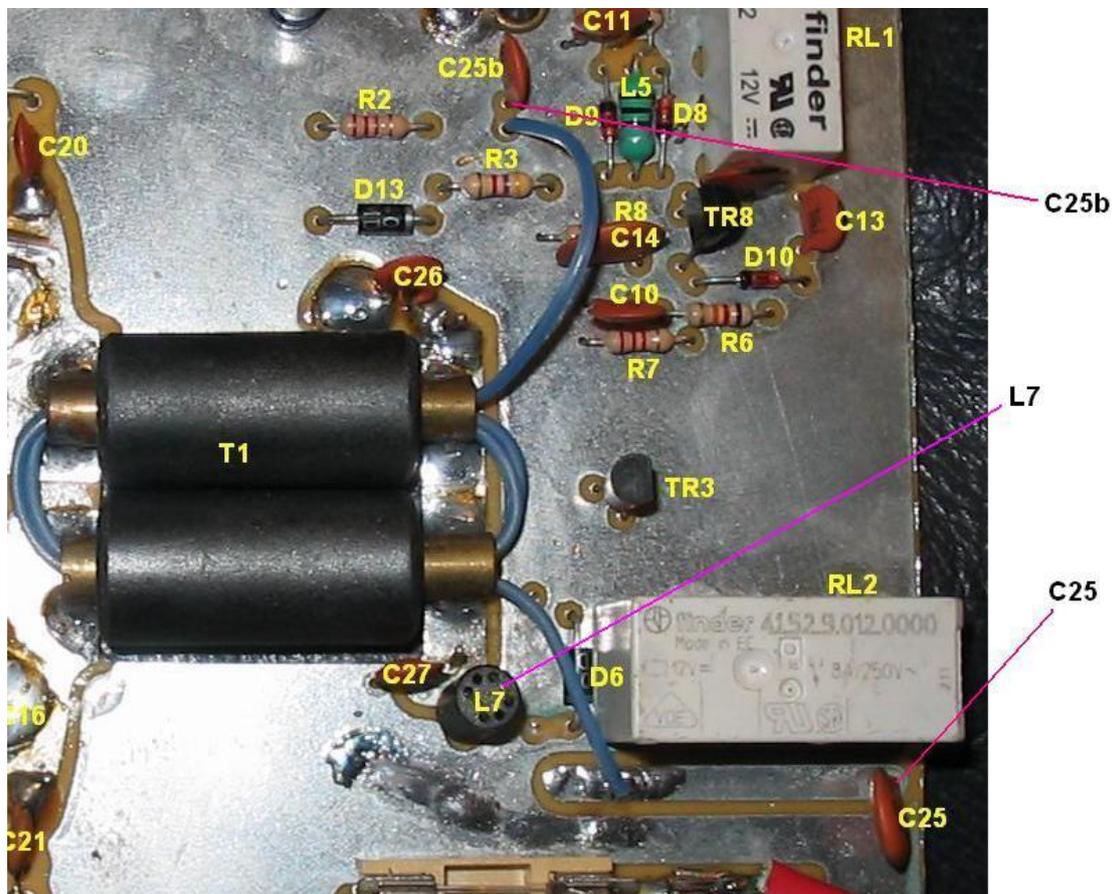
Repeat this test but this time checking for continuity between the ANT coax inner and the appropriate legs of both C25 and C25b. Actually make contact with the capacitor legs as otherwise a dry joint may be missed.

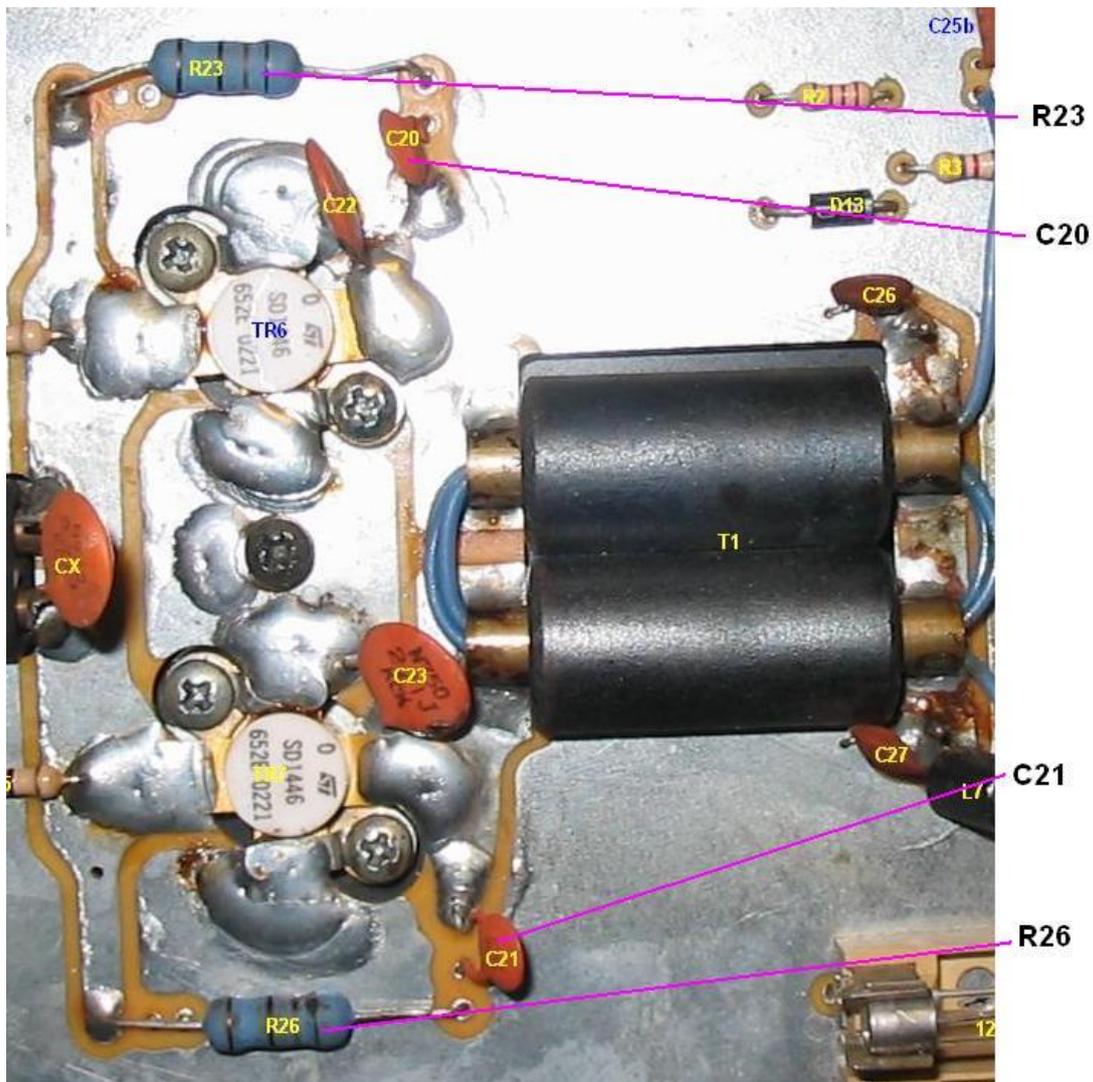
Visually check out R23/C20 and R26/C21 to ensure they do not have any dry joints.

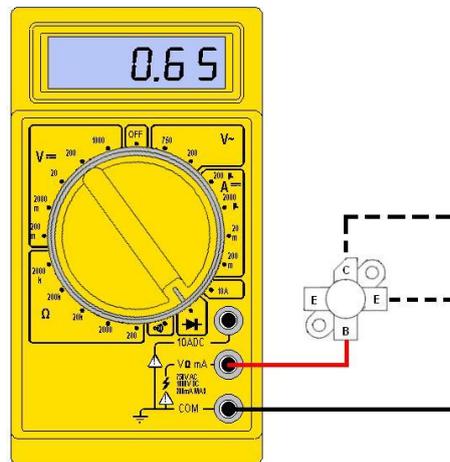
Once you have fully isolated the Base Tab, then you can check the transistor using a Multimeter, preferably one that has a diode check function.

Connect the Red lead to Base and the Black lead to Emitter, the meter should show approximately 0.65. Then check that a similar reading is obtained with the Red lead on the Base and the Black lead on the Collector. Most meters show OL if the transistor is open circuit or 0.00 if the transistor is short circuit. If a short circuit reading is indicated then you will find that reversing the leads to Base and Emitter will give the same short circuit reading.

You should find that if a correct 0.65 reading is obtained as shown then reversing the leads i.e. Black lead to Base and Red lead to either Emitter or Collector should give an open circuit reading, typically shown on most meters as OL.

The normal failure mode for these transistors is either an open circuit Base to Emitter connection or else a short circuit within the transistor between Base and Emitter. The author has adopted the following tests which so far have been beneficial in finding the defective device.

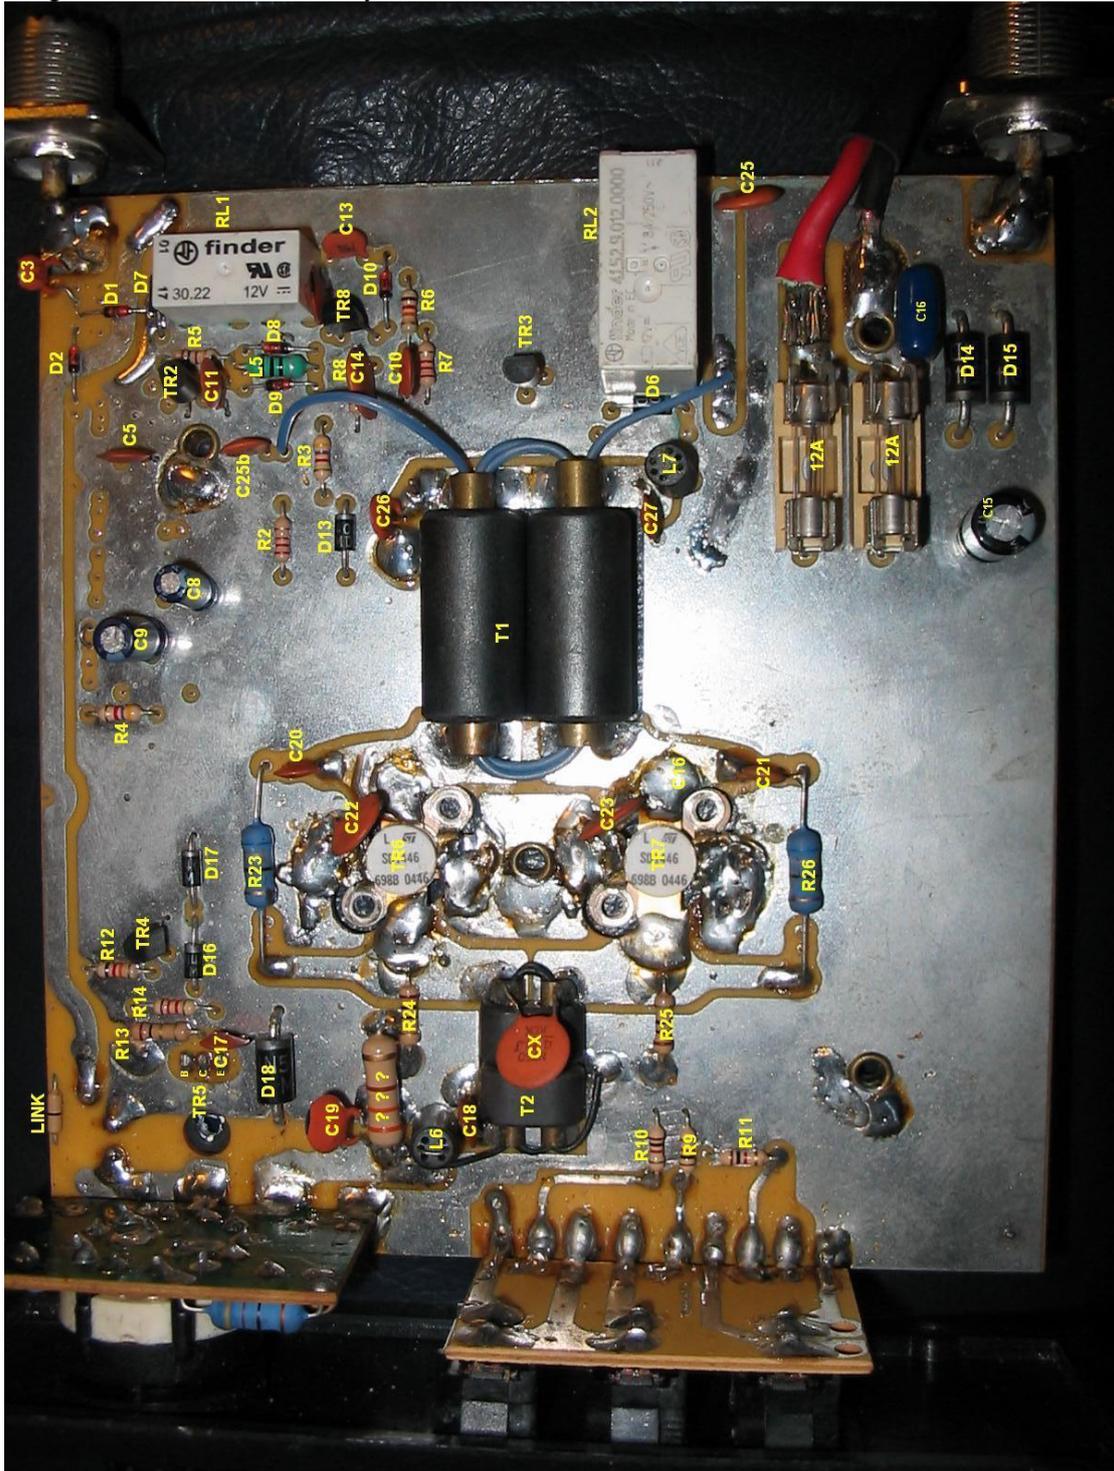
Single RF sensor model - layout

Note how the resistors R15 and R16 have been removed and the drive now goes directly into the power control board via a circuit pad underneath. This may have been done to cater for 4 Watt output UK rigs as the additional attenuation may have been intended to handle higher inputs, e.g. 10 Watts, from continental rigs. It is a puzzle why the 330 Ohm resistor has been added on the power control output pad. If you look closely to the left of C9 (middle of board – far left) you will see the wire link that connects TR1 and TR3 to a common single RF sensor.

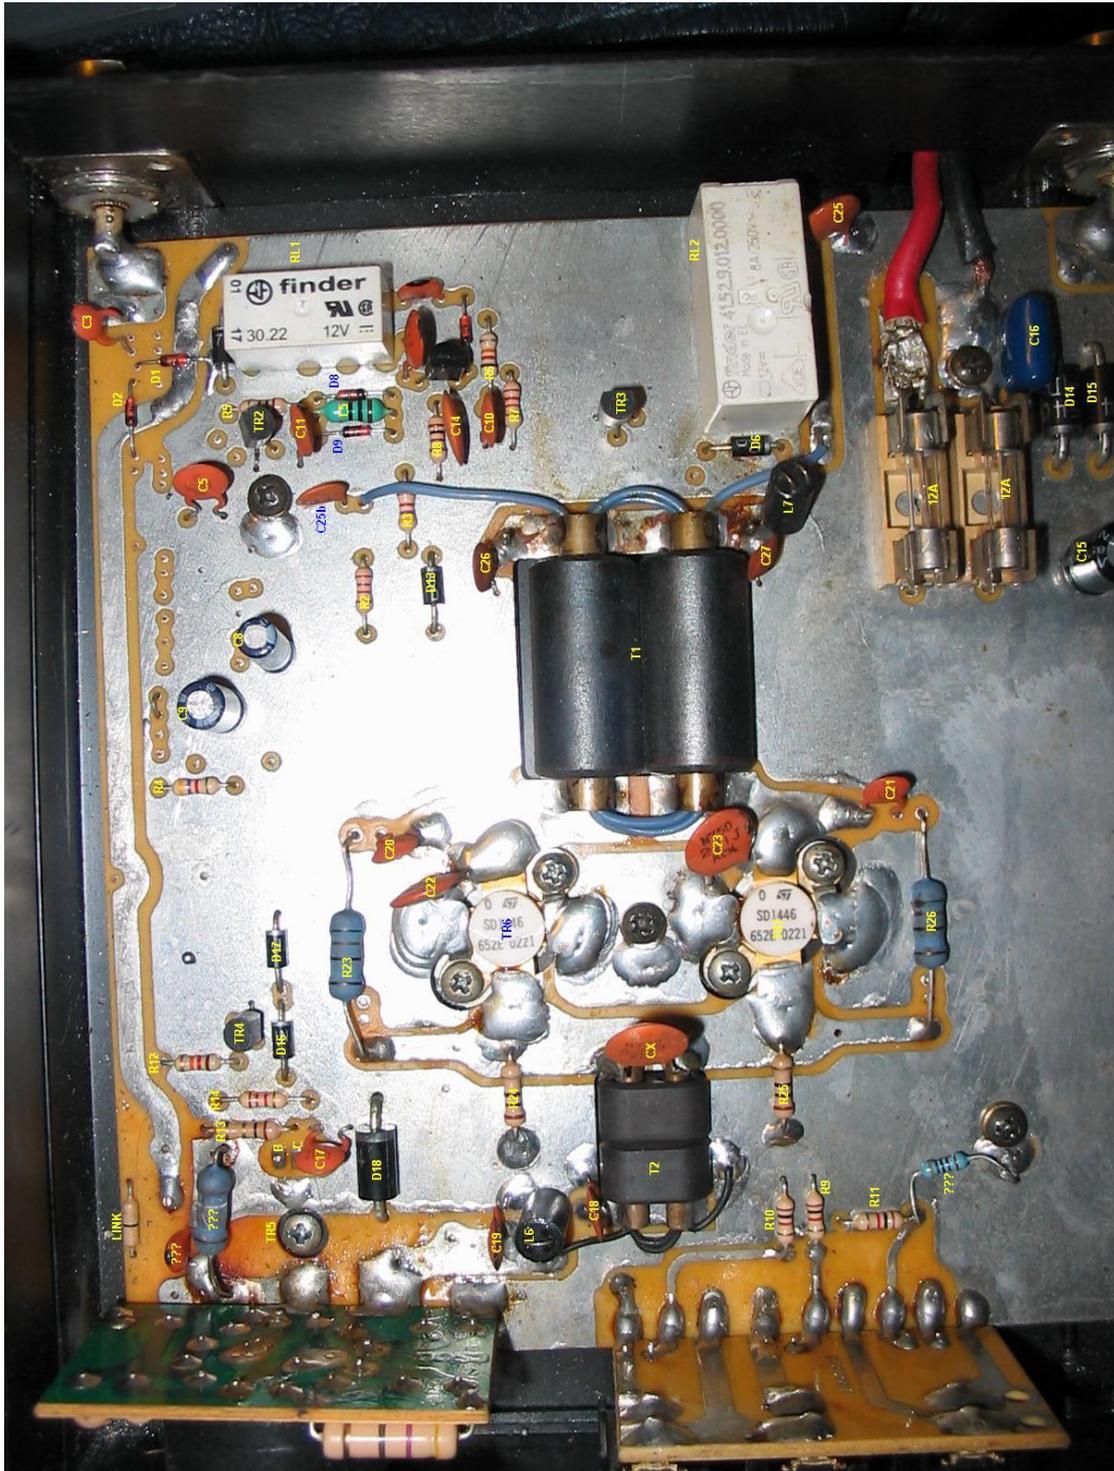
Another slightly different single sensor model – layout

It is possible that the 4k7 resistor shown lower right hand side which connects with R11 was added to stop the dim glow of the TX LED when the AMP switch is set to ON and the driving rig is not keyed up. Note also that R15 and R16 have also been removed so the drive goes directly into the power control board. However it is the input pad this time that has a 390 Ohm resistor and 47pF capacitor added.
