So another Quad 405 comes in for some tender care, this one is a 405-2 with series 6 circuit boards. It is very similar to the last 405 that I repaired; I just had to add R18 to the photo I had taken before.

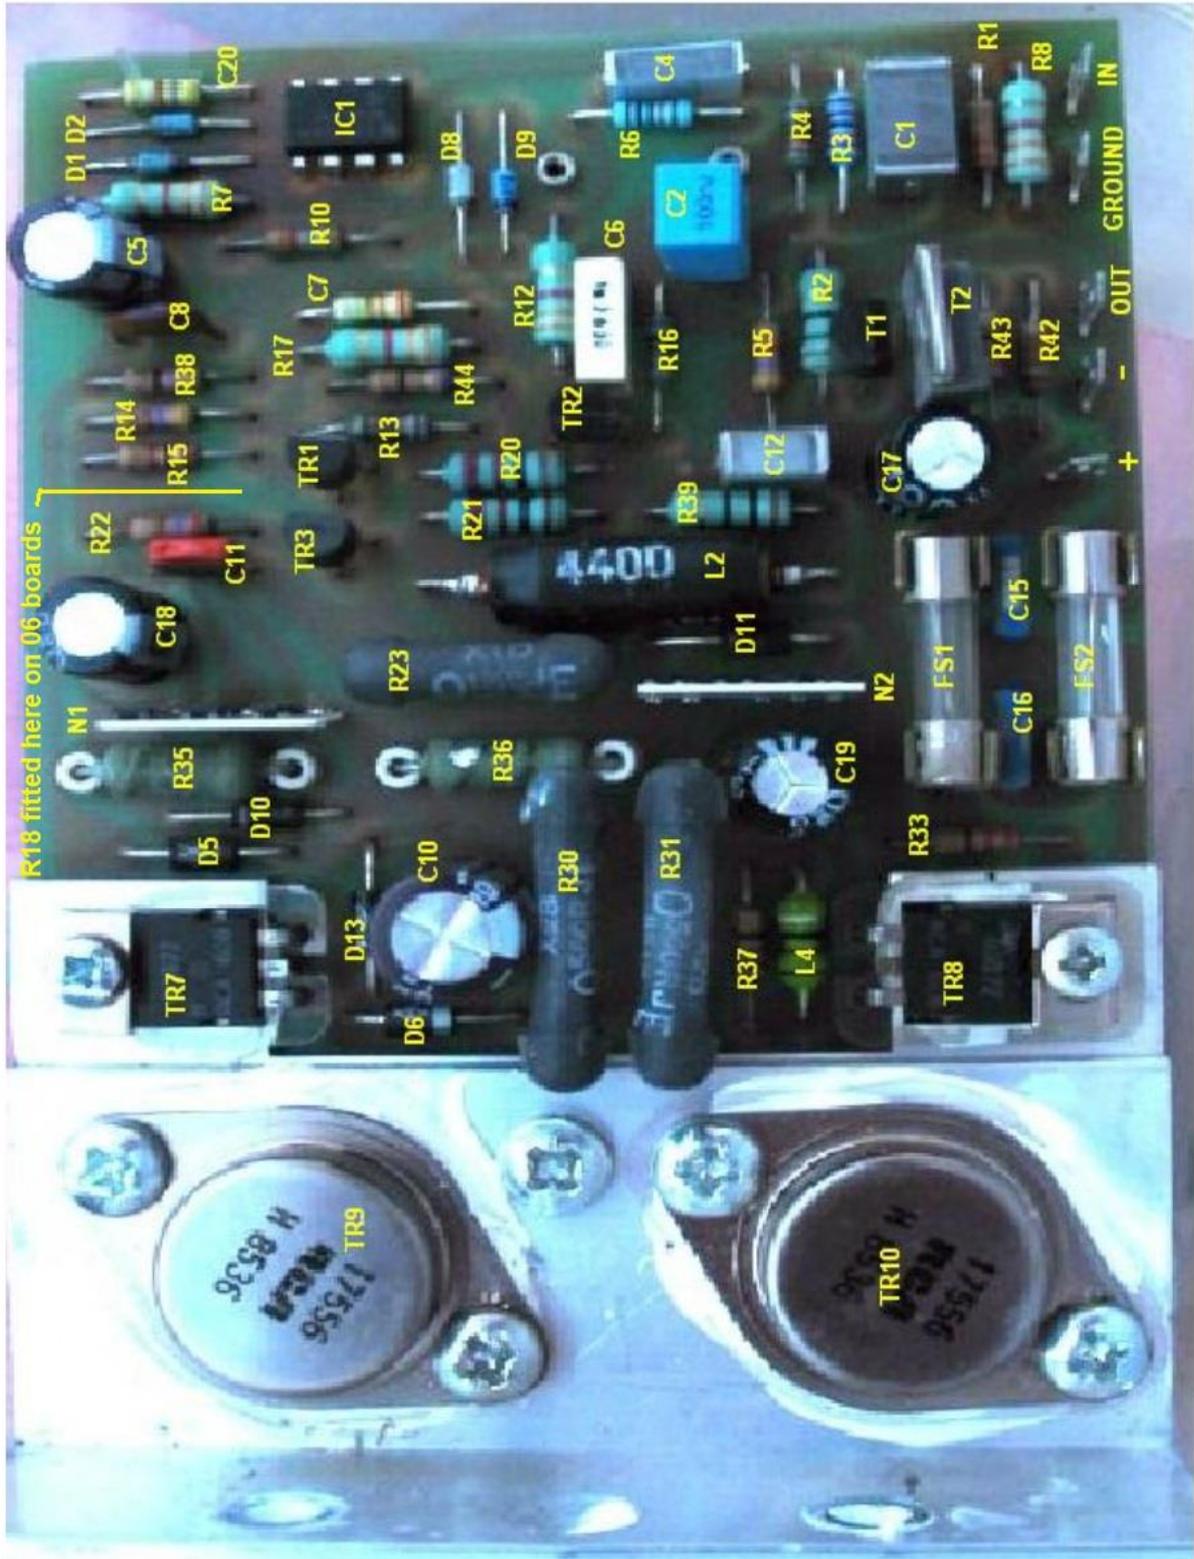
A visual gave away some clues as to what I had to expect, this for reference, is the Right channel.

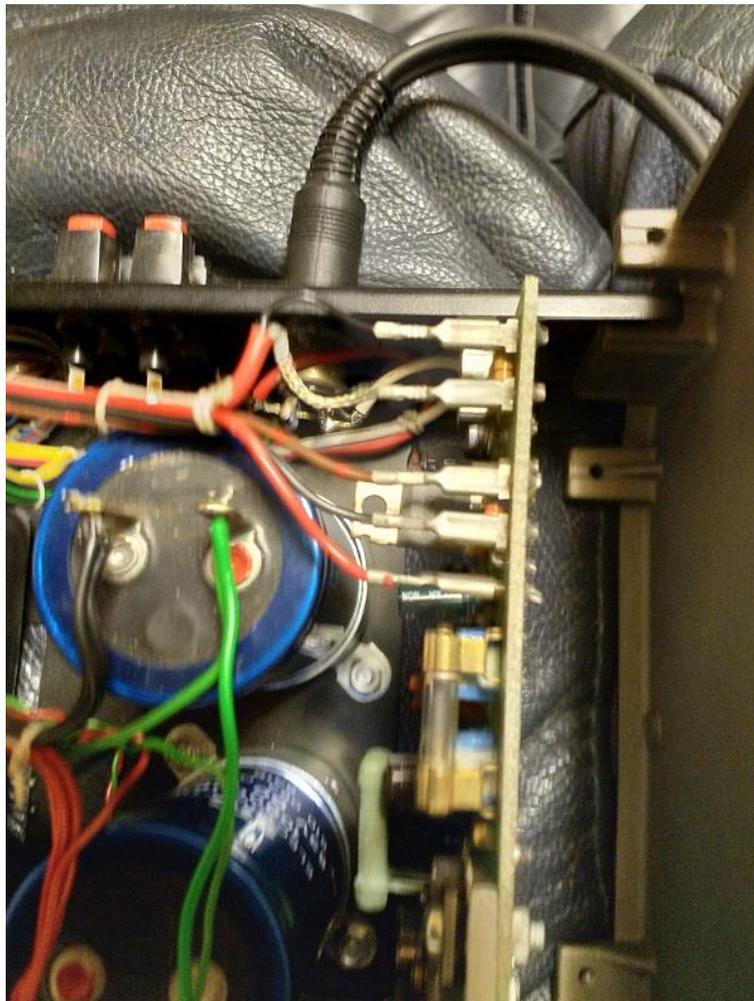
Just for reference, a photo showing the edge connections on the faulty board.

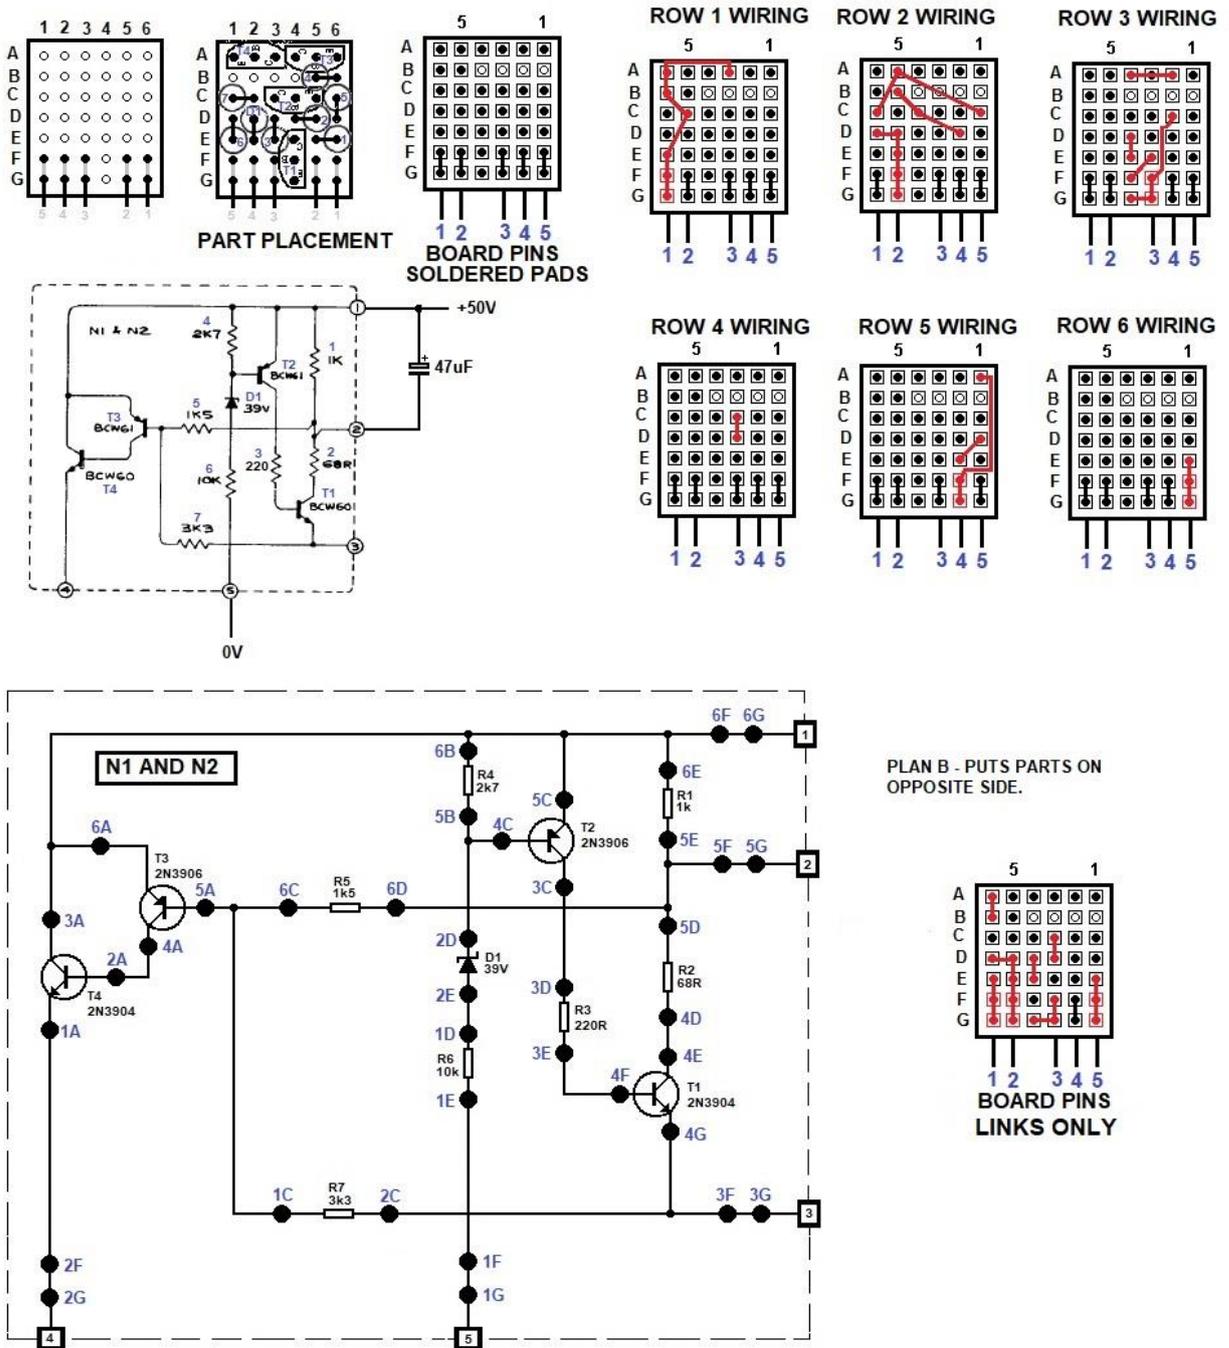
PLAN B!

PLAN B - PUTS PARTS ON OPPOSITE SIDE.

It has to be made very small to fit into the available space. I need to acquire some isolated pad board then get the parts and some very fine linking wire. ☹️ Thought my Pin and Wire days were over.

Suggested build is to fit all components as shown above in part placement, hopefully there is more room than indicated! Wire for pins can be 20 SWG tinned copper such as RS 355-063. Note how it is threaded from component side then routed back (Pads F & G) to give good support and prevent pad lift.

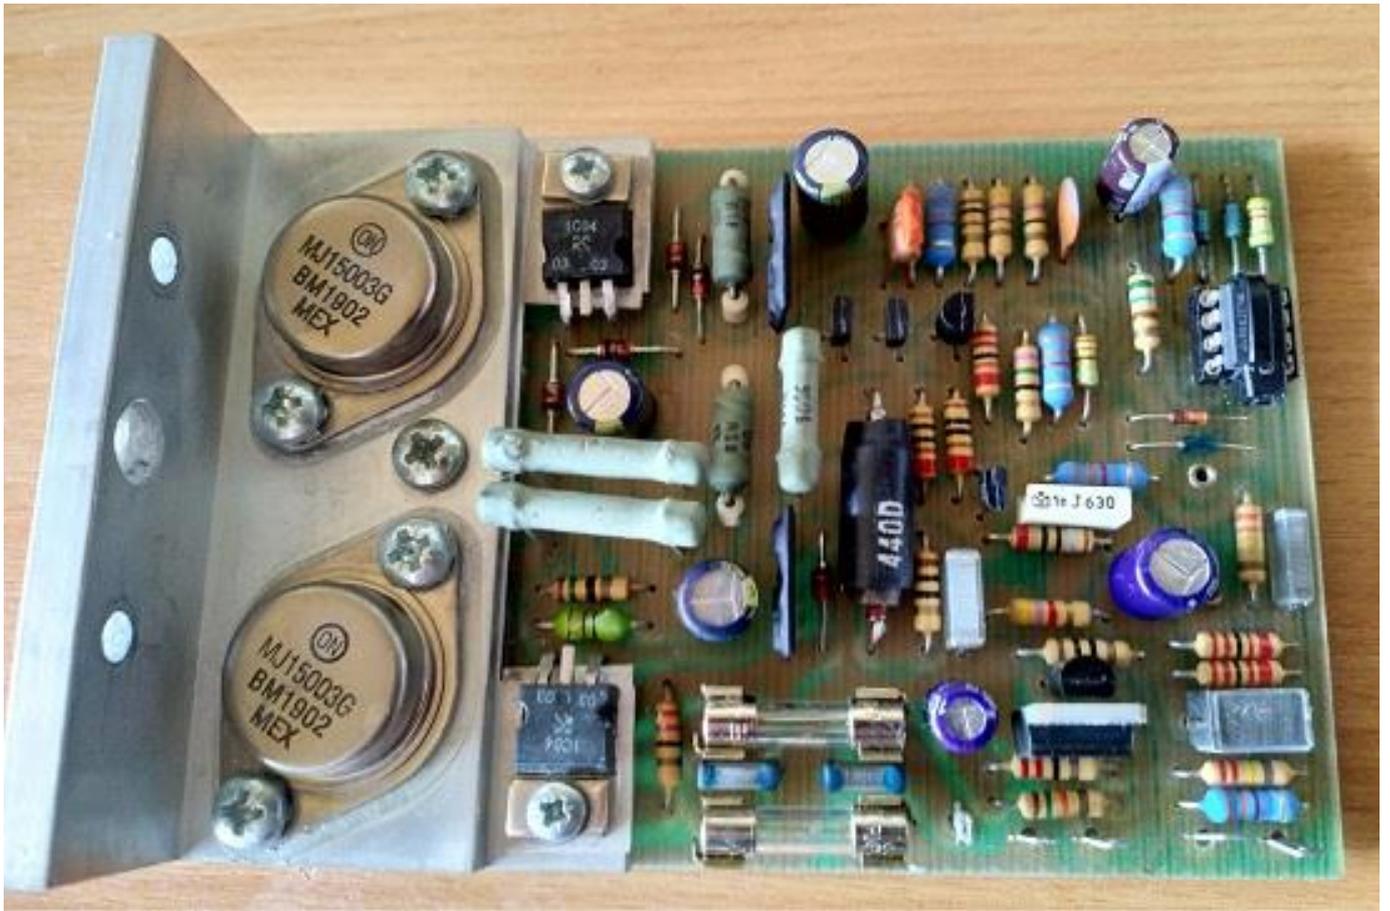
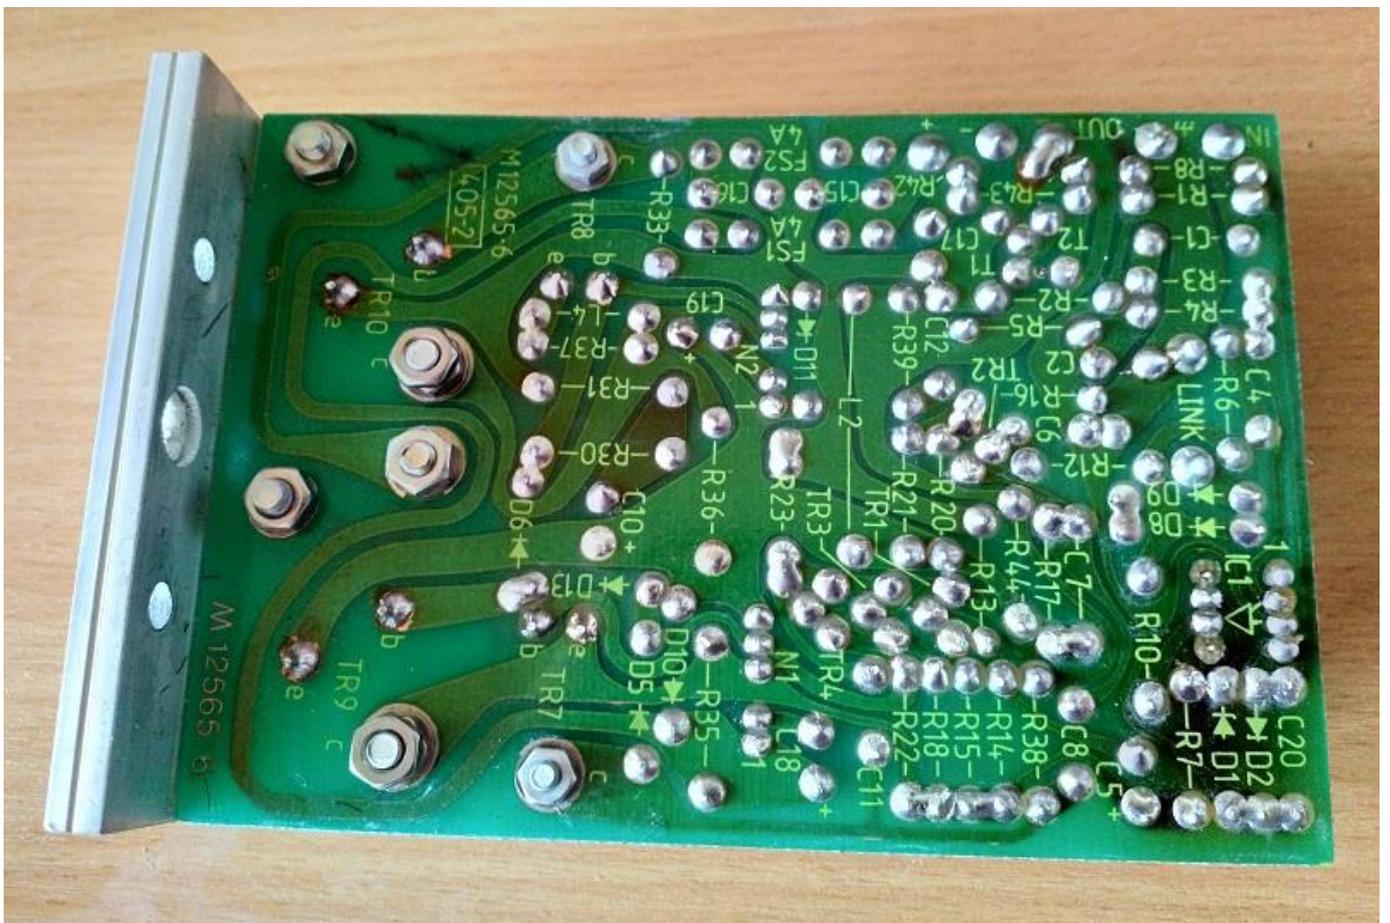
Washed and ready for Test

For those without a Variac, testing is a real Heart in the Mouth moment. Fortunately I have a Variac and I was able to raise the power input VERY slowly whilst monitoring the all-important DC level at the speaker sockets. These were loaded with high power 8 Ohm non-inductive loads and monitored by a dual channel oscilloscope. All looked well so a 1 kHz low distortion sine wave was applied and outputs checked for obvious distortion.

Everything looked fine, no crazy offset voltages on the outputs and they can be pushed to well over 40 Watts. I compared the distortion of the repaired channel (Right) with the good working Left channel. Both channels show 0.05% at near maximum output so I consider this to be good.

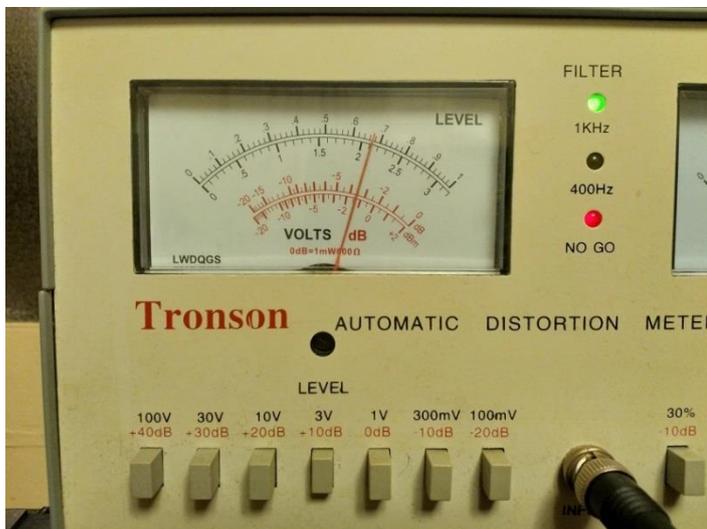
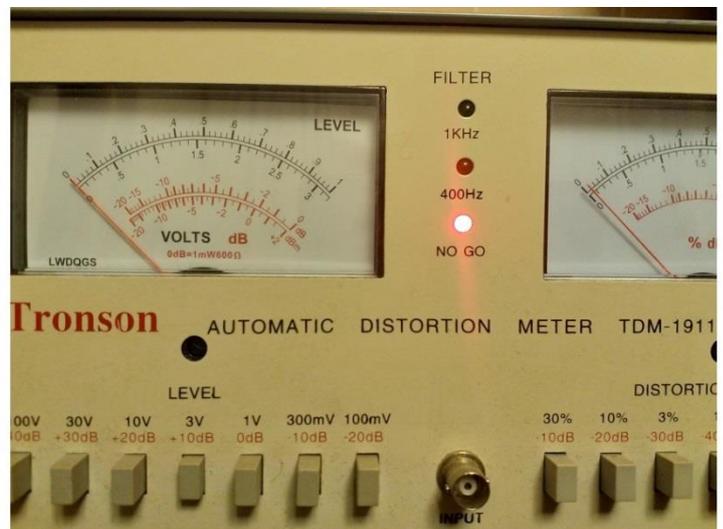
Don't be put off by the Red NO GO lamp; it is in its dim condition as it sees a suitable input signal. Below are two pictures, the right hand shows the lamp difference when the signal input is insufficient.
