REPAIRING THE RM KL400 LINEAR AMPLIFIER

Les Carpenter G4CNH December 2012 The following is a step by step guide to fixing your KL400 amplifier.

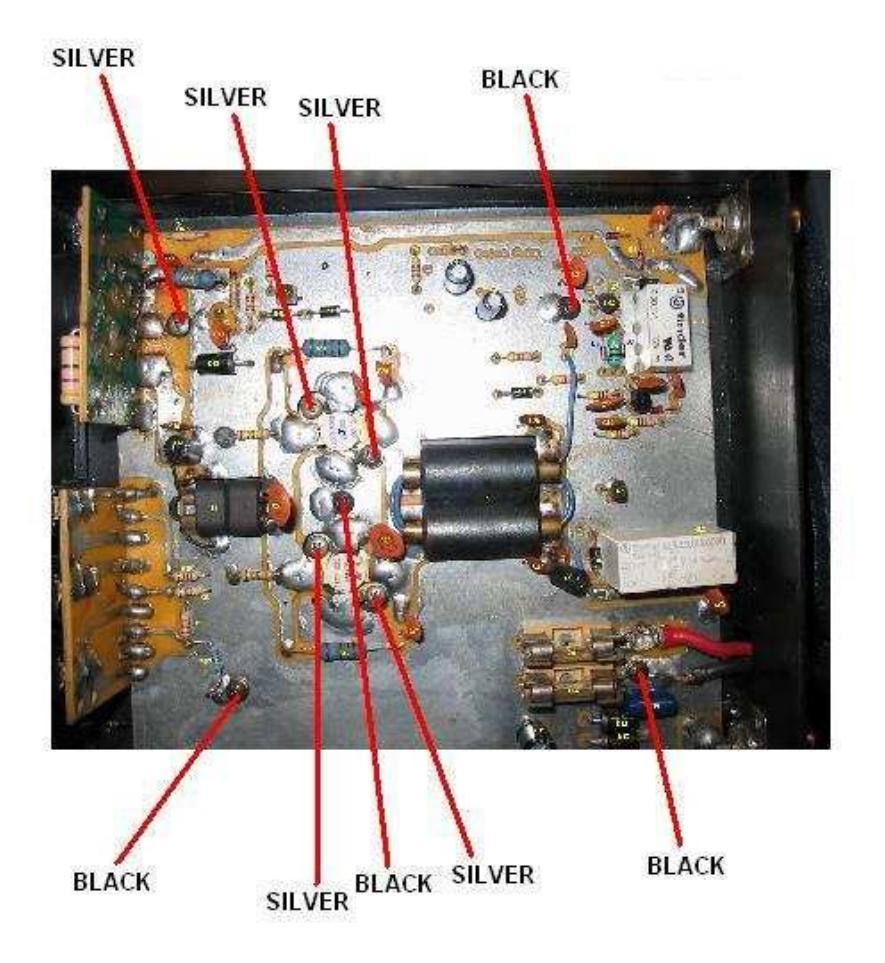
Remove two screws from each coax socket. Remove four screws securing front panel. Remove four Black and five Silver screws as shown below:-

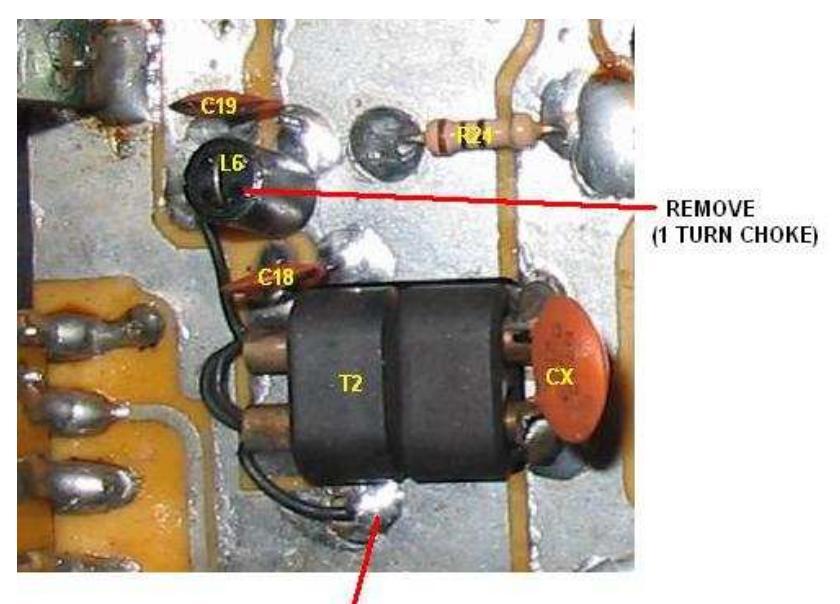
LIFT FROM EARTH

Using a soldering iron, remove L6, L7 and disconnect earthy end of T2 primary:-

<u>Reason:</u> Removing L6 isolates PA Bias Supply, removing L7 isolates 12V from the final transistors and removing ground wire from T2 isolates the DC control switch to allow DC testing of the Power switch board and its associated components.

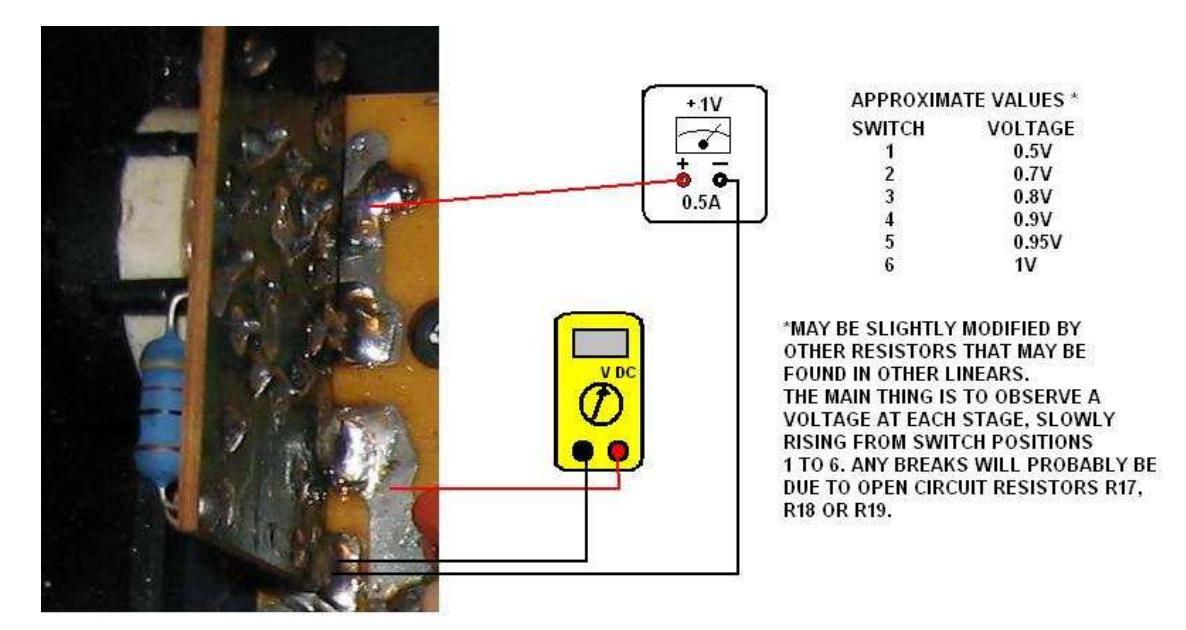
Apply 1 Volt to the power switch wiper A and monitor the output using a Multimeter and DC Test Circuit as shown below:-.

(Note a 1.5V cell can suffice but expect slightly higher voltages)

This should have proved Power Control Switch, R17, R18, R19, R20, R21 and R22.

If you found some switch positions faulty then it is highly likely that one of the attenuator resistors mounted on the switch board is faulty. A common failure is an open circuit 10 Ohm resistor R19.

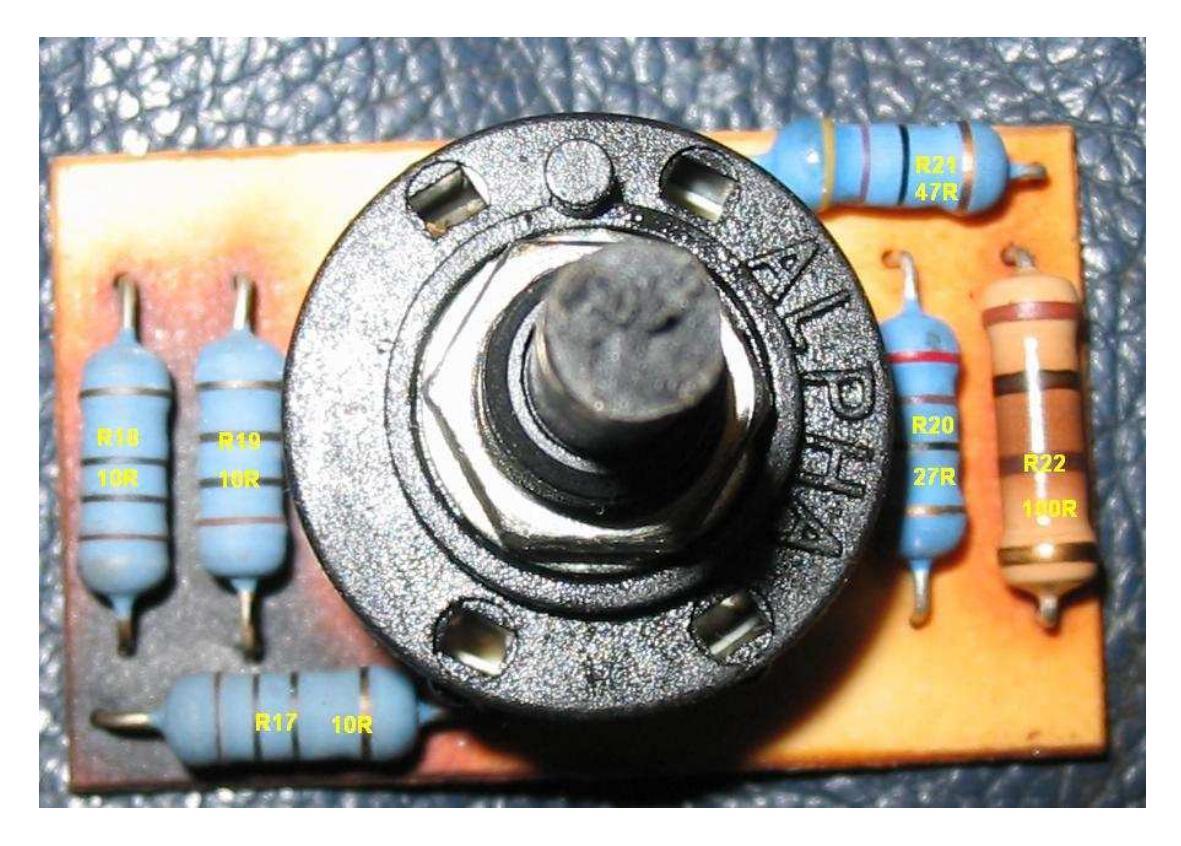
Set the switch fully anti-clockwise (Position 1) and using the Multimeter, check across each of the resistors for the values shown with no more than 5% error. Expect the 10 Ohm resistors to be between 9.5 and 10.5 Ohms, the 27 Ohm resistor to be between 25.6 and 28.3 Ohms, the 47 Ohm resistor to be between 44.6 and 49.3 Ohms and the 100 Ohm resistor between 95 and 105 Ohms. Replace as necessary.

Now if you dislodged the indent washer, simply refit to the switch with the tab on the washer located in one of the slots. Turn the switch from position 1 and count 2, 3, 4, 5, 6 before the switch rotation stops. If you have too many or too few stops, reset switch to position 1, relocate the tab on the washer to another slot and repeat until all six positions can be made. Carefully replace the switch into the front panel and secure with the nut and washers previously removed, making sure the indent washer does not fall out while you are doing it!

Now hold the two boards together at 90 degrees and reflow solder onto the three pads. Replace the knob and tighten the grub screw when the knob pointer indicates correctly on the front panel markings.

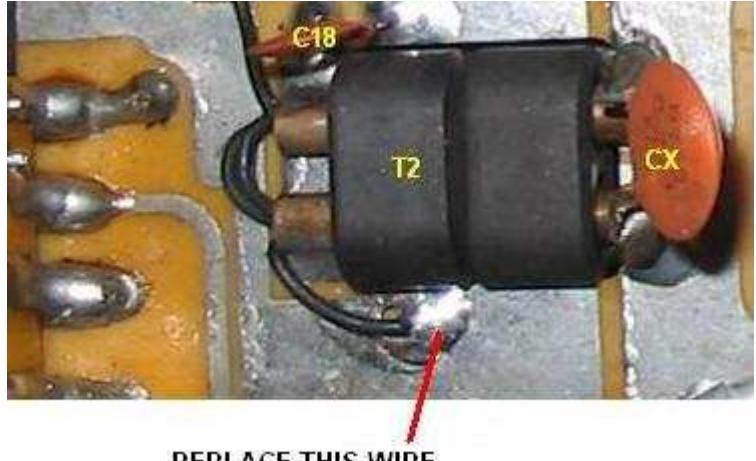
REPLACE THIS WIRE

Reconnect wire previously removed from T2 to ground plane.

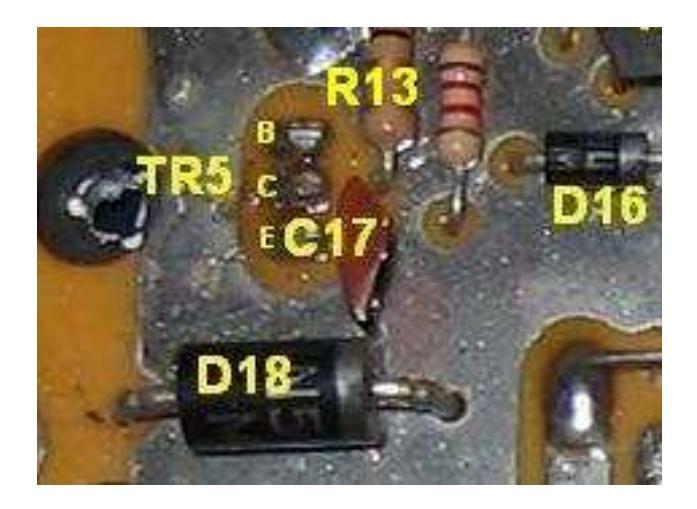
Check with a Multimeter that there is 12V available on TR5 collector (C). (Proves R13 is not open circuit or C17 is short circuit)

R13 acts as a safety fuse resistor. If R13 is open circuit then check TR5 which probably no longer acts as a constant current source and the reason for R13 failure.

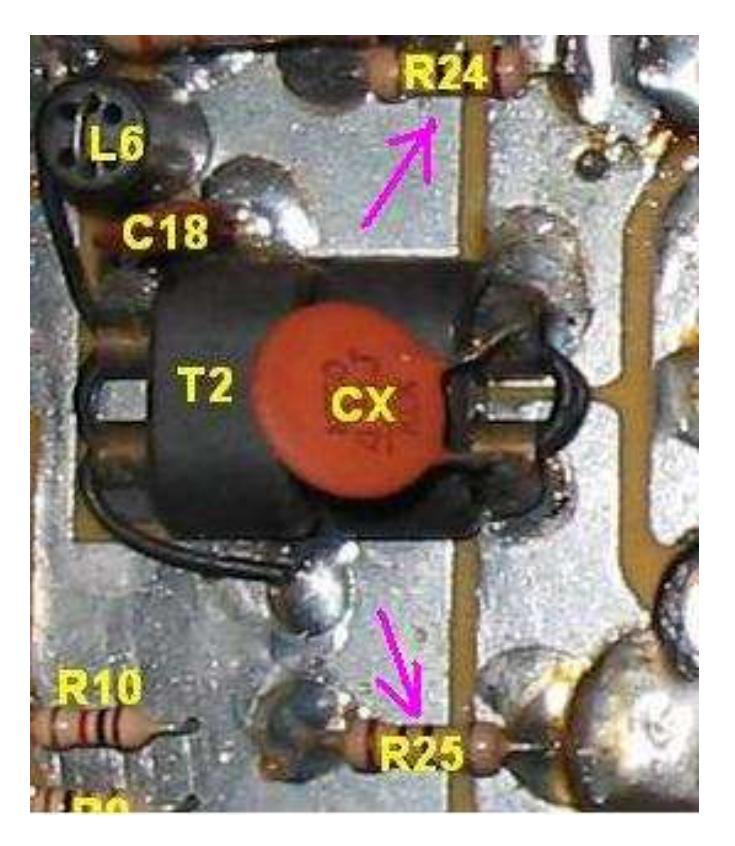
Replace L6 (1 turn choke) then by briefly keying rig, verify that the bias voltage is present across R24 and R25.

(Proves C18 not short circuit and that the circuit board track to and including T2 is not open circuit)

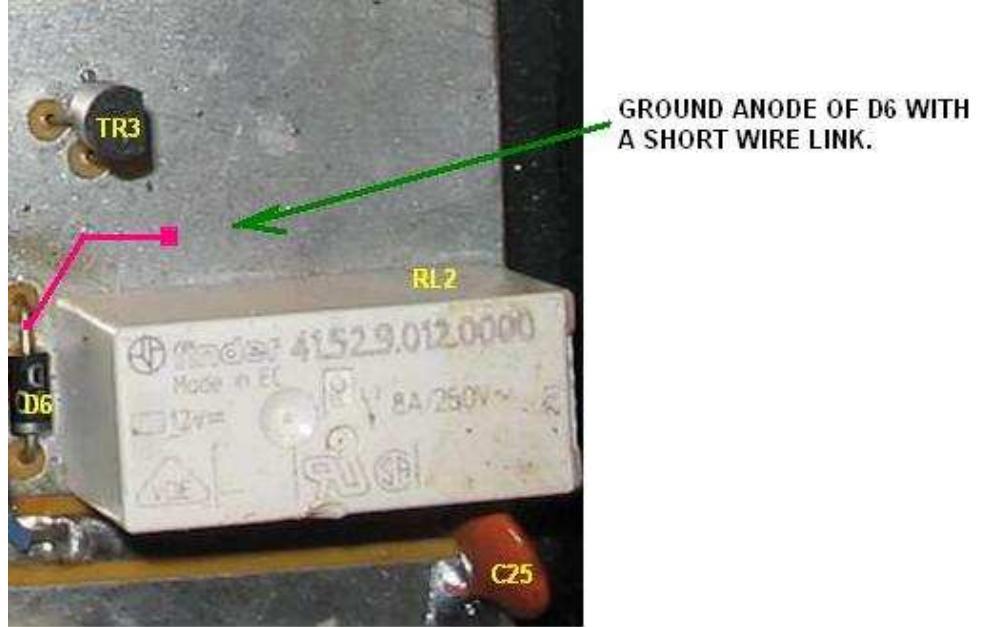
The easiest way to make RL2 operate is to apply a short link wire between the ground plane and the anode of D6.

Now these tests have to be done as briefly as possible because TR5 is not mounted to the heatsink case and will get hot very quickly!

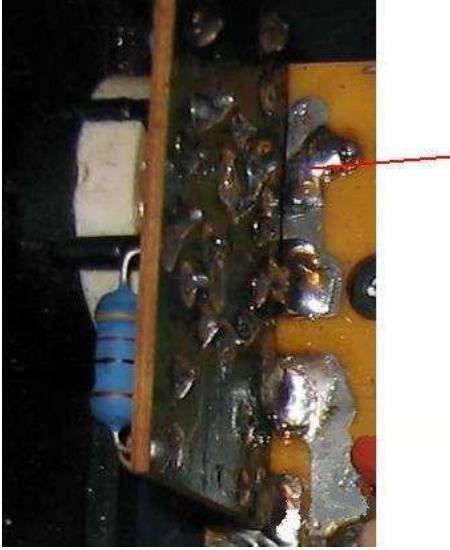
Using the Multimeter as a continuity tester, connect it between the inner of the RIG coax socket (Top right with front panel to your left) and the power control board input pad. This is the pad used in the 4th Test where the 1V test voltage was applied.

Briefly apply the 12V supply and check continuity is established then switch off the 12V supply.

(If no continuity is established, an open circuit can be caused by poor contact from one side of the main board to the other side, due to corrosion on connecting throughwires. The Multimeter will be able to detect where the disconnection is occurring and where application of fresh solder is required).

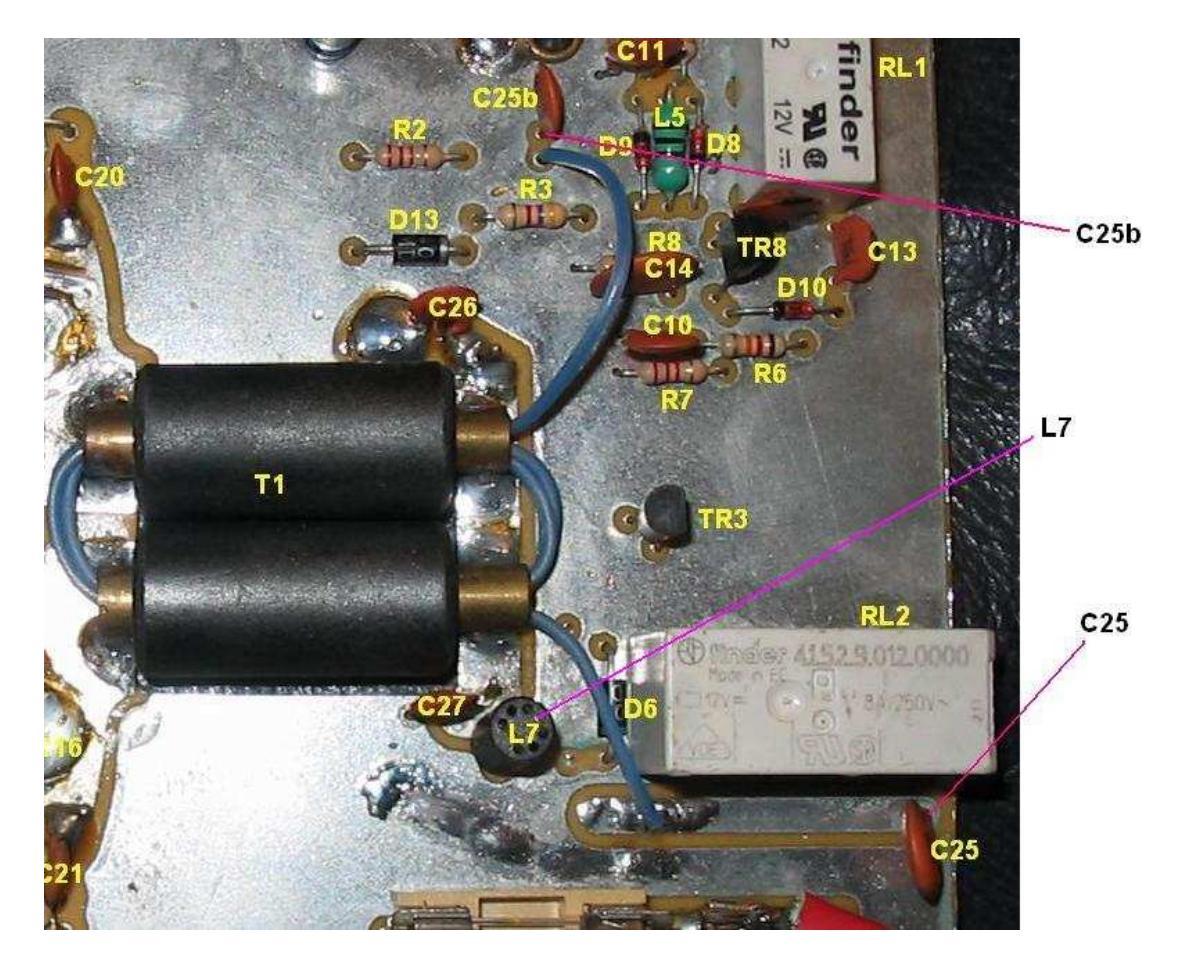
Now connect the Multimeter between the ANT coax inner (Bottom right with front panel to your left) and the Blue wire wound around T1. Briefly apply the 12V supply and check continuity is established then switch off the 12V supply.

Repeat this test but this time checking for continuity between the ANT coax inner and the appropriate legs of both C25 and C25b. Actually make contact with the capacitor legs as otherwise a dry joint may be missed.

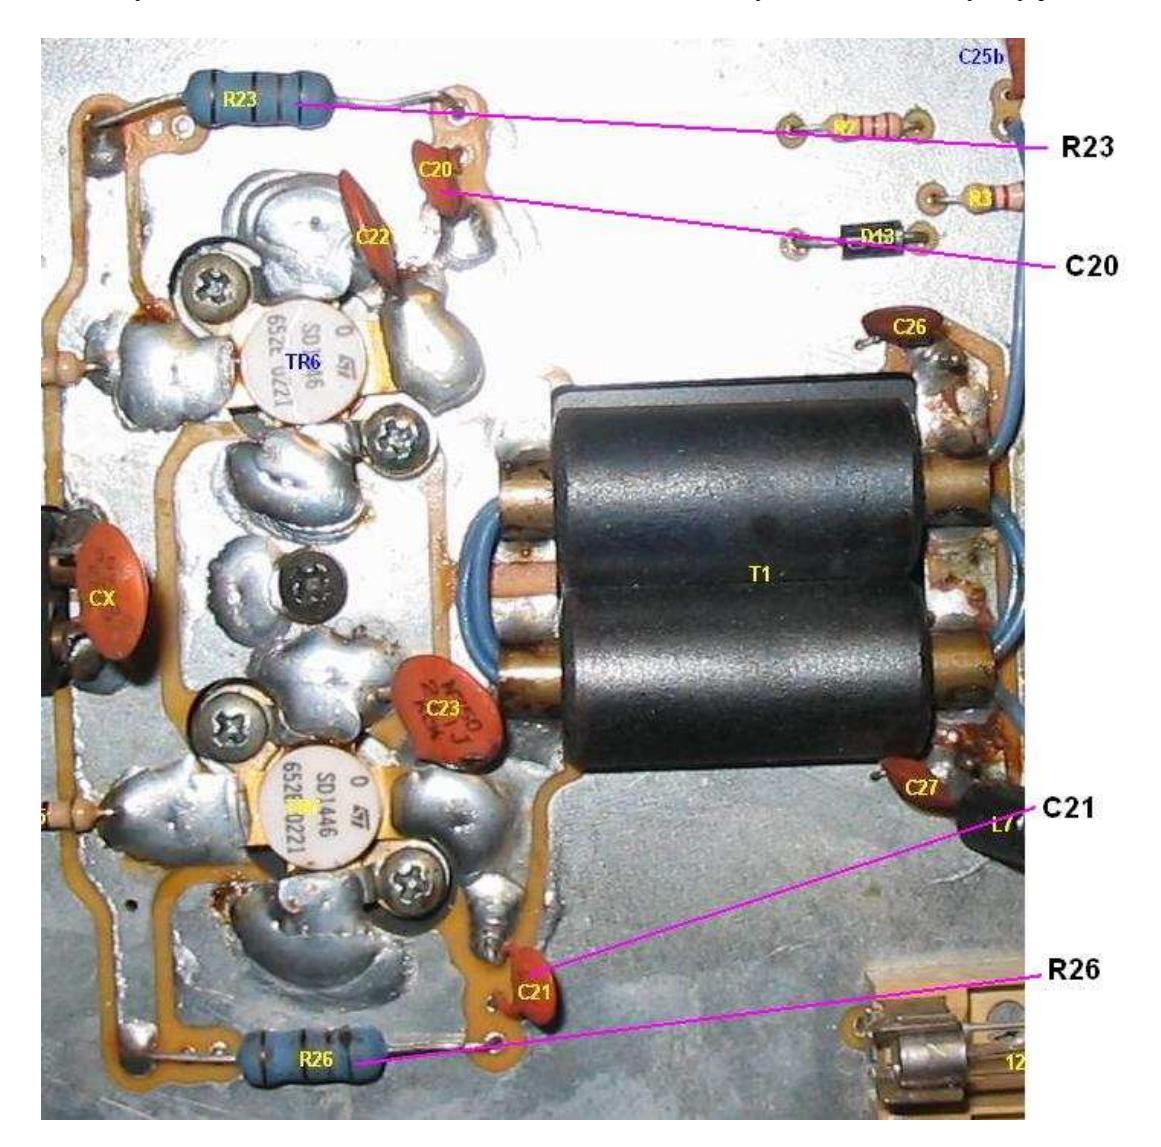
Remove the link on D6 and replace L7 (2 turn choke).

Visually check out R23/C20 and R26/C21 to ensure they do not have any dry joints.

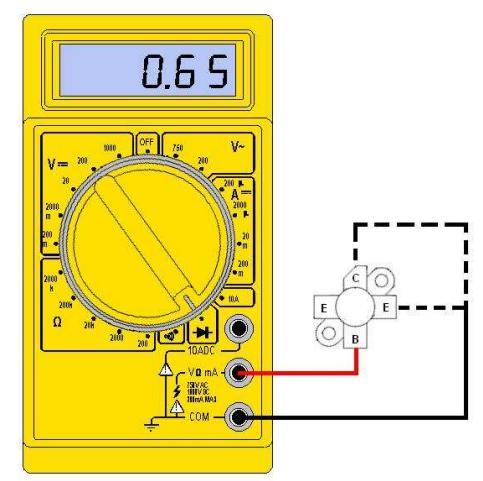
Once you have fully isolated the Base Tab, then you can check the transistor using a Multimeter, preferably one that has a diode check function.

Connect the Red lead to Base and the Black lead to Emitter, the meter should show approximately 0.65. Then check that a similar reading is obtained with the Red lead on the Base and the Black lead on the Collector. Most meters show OL if the transistor is open circuit or 0.00 of the transistor is short circuit. If a short circuit reading is indicated then you will find that reversing the leads to Base and Emitter will give the same short circuit reading.

You should find that if a correct 0.65 reading is obtained as shown then reversing the leads i.e. Black lead to Base and Red lead to either Emitter or Collector should give an open circuit reading, typically shown on most meters as OL.

The normal failure mode for these transistors is either an open circuit Base to Emitter connection or else a short circuit within the transistor between Base and Emitter. The author has adopted the following tests which so far have been beneficial in finding the defective device.

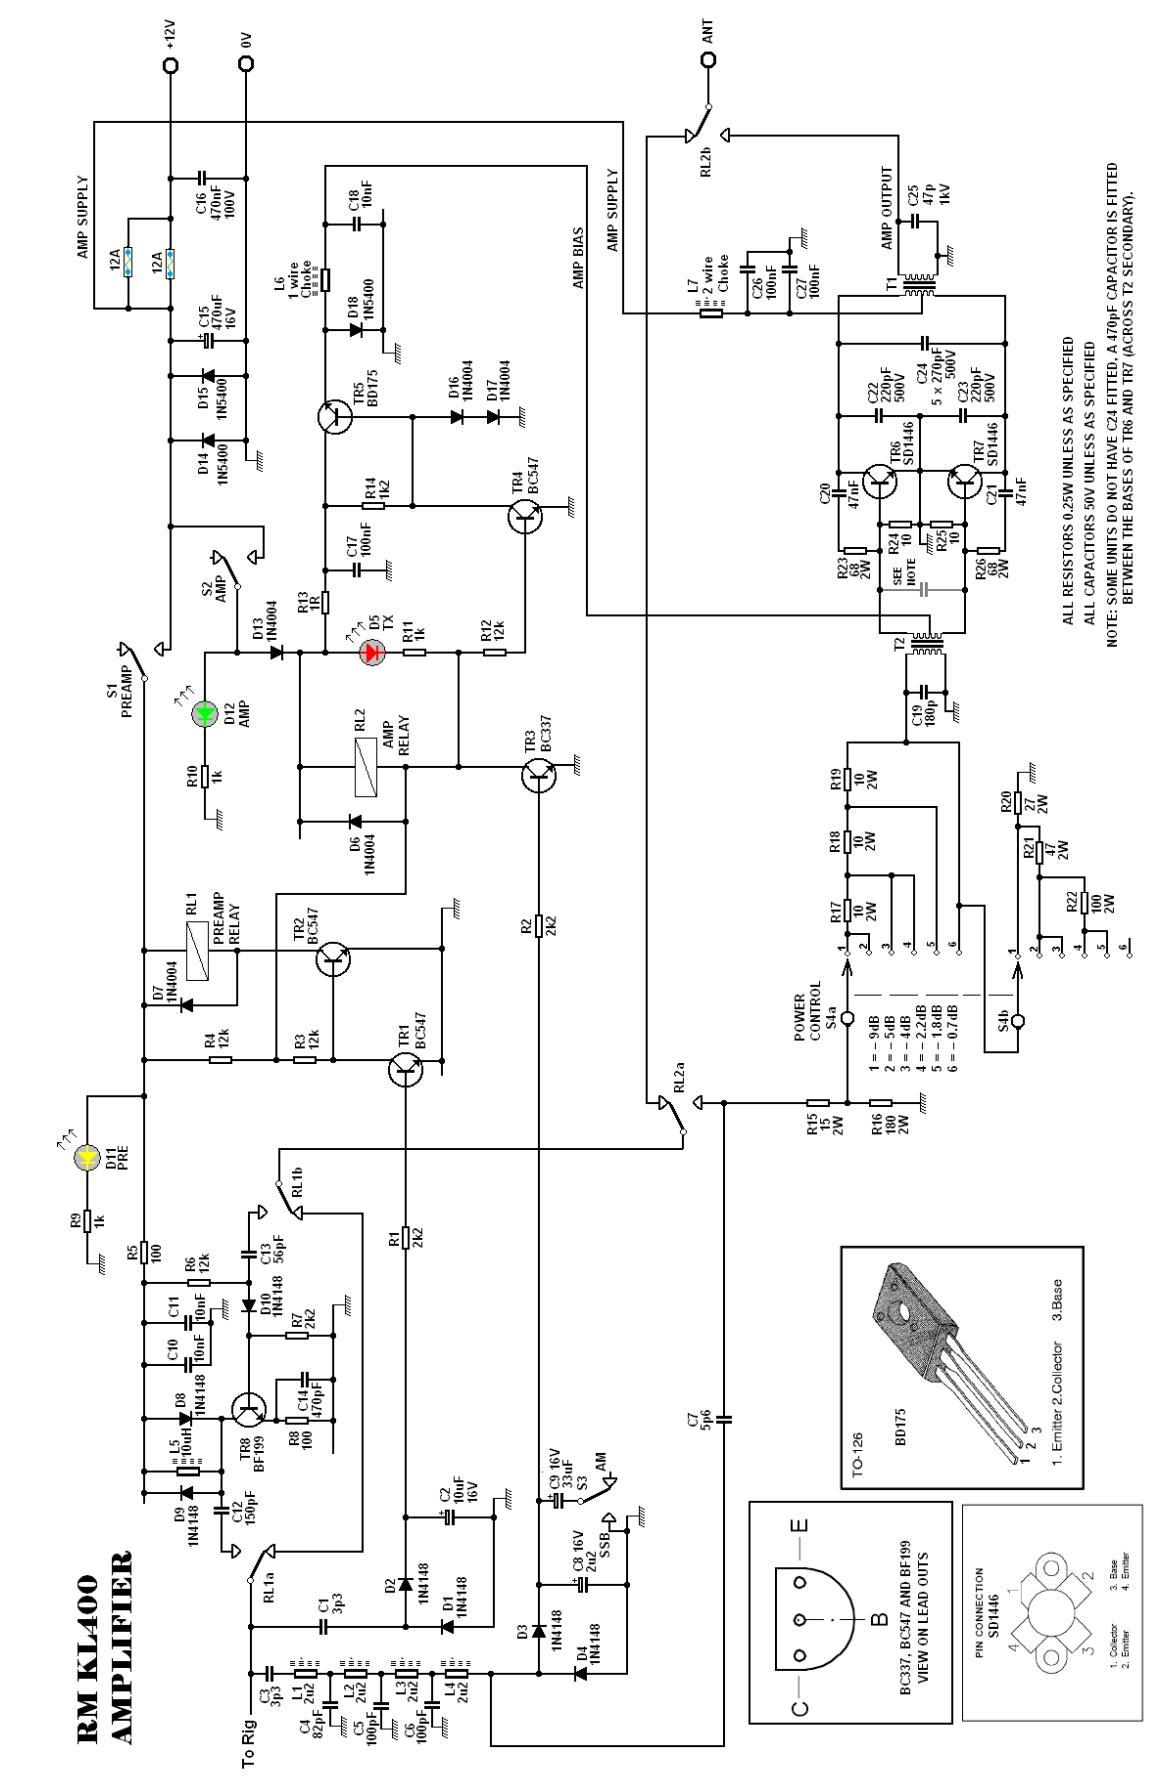
Original KL400 circuit diagram that used two RF sensor circuits.

With all switches OFF, the signals arriving at the ANT socket are routed to the RIG socket via two contacts in RL2 and two contacts in RL1. If the PRE switch is set to ON, the PRE LED illuminates with R9 providing current limit for the LED at approximately 10mA. Relay RL1 operates due to its driving transistor TR2 being turned on by forward bias current supplied by R3 and R4, TR1 at this time is turned off. D7 is a back stop diode to prevent damage to TR2 when the relay is de-energised. The first contact set of the relay switches the input signal to the base of TR8 via D10 and C13. D10 is forward biased by R6 and applies approximately 1.7V to the base of TR8 by the action of the diode and potential divider formed with R7. The transistor amplifies the input signal with the output developed across choke L5 which is coupled to the rig via C12 and the second contact set of RL1. Diodes D8 and D9 would appear to limit the signal being developed across the choke in situations where there is a strong local transmission being received. However we shall see later that they perform an even more important duty.

If the rig is keyed up at this time then some of the 4 Watts input at the rig socket is taken via C3 to D1 and D2. D1 removes the negative going excursion of this sampled signal whilst D2 rectifies the positive going excursion and charges C8. C5 removes any high frequency 27MHz carrier signal at this point. The positive DC voltage developed across C5 is used to bias ON the transistor TR1 with R1 acting as a series limiter to prevent excess base to emitter current flow within TR1. TR1 having turned ON, effectively grounds the base of TR2, starving it of base current and turning TR2 OFF. Relay RL1 will now de-energise to switch the preamp out of circuit such that the rig output can now go direct to the ANT socket via the contacts of RL2. Note that there is a slight delay by the relay RL1 in doing this so the full 4 Watts of rig power will be present on C12 for a short time. This is where the diodes D8 and D9 come into play again, by limiting the amount of RF signal briefly appearing on the transistor TR8.

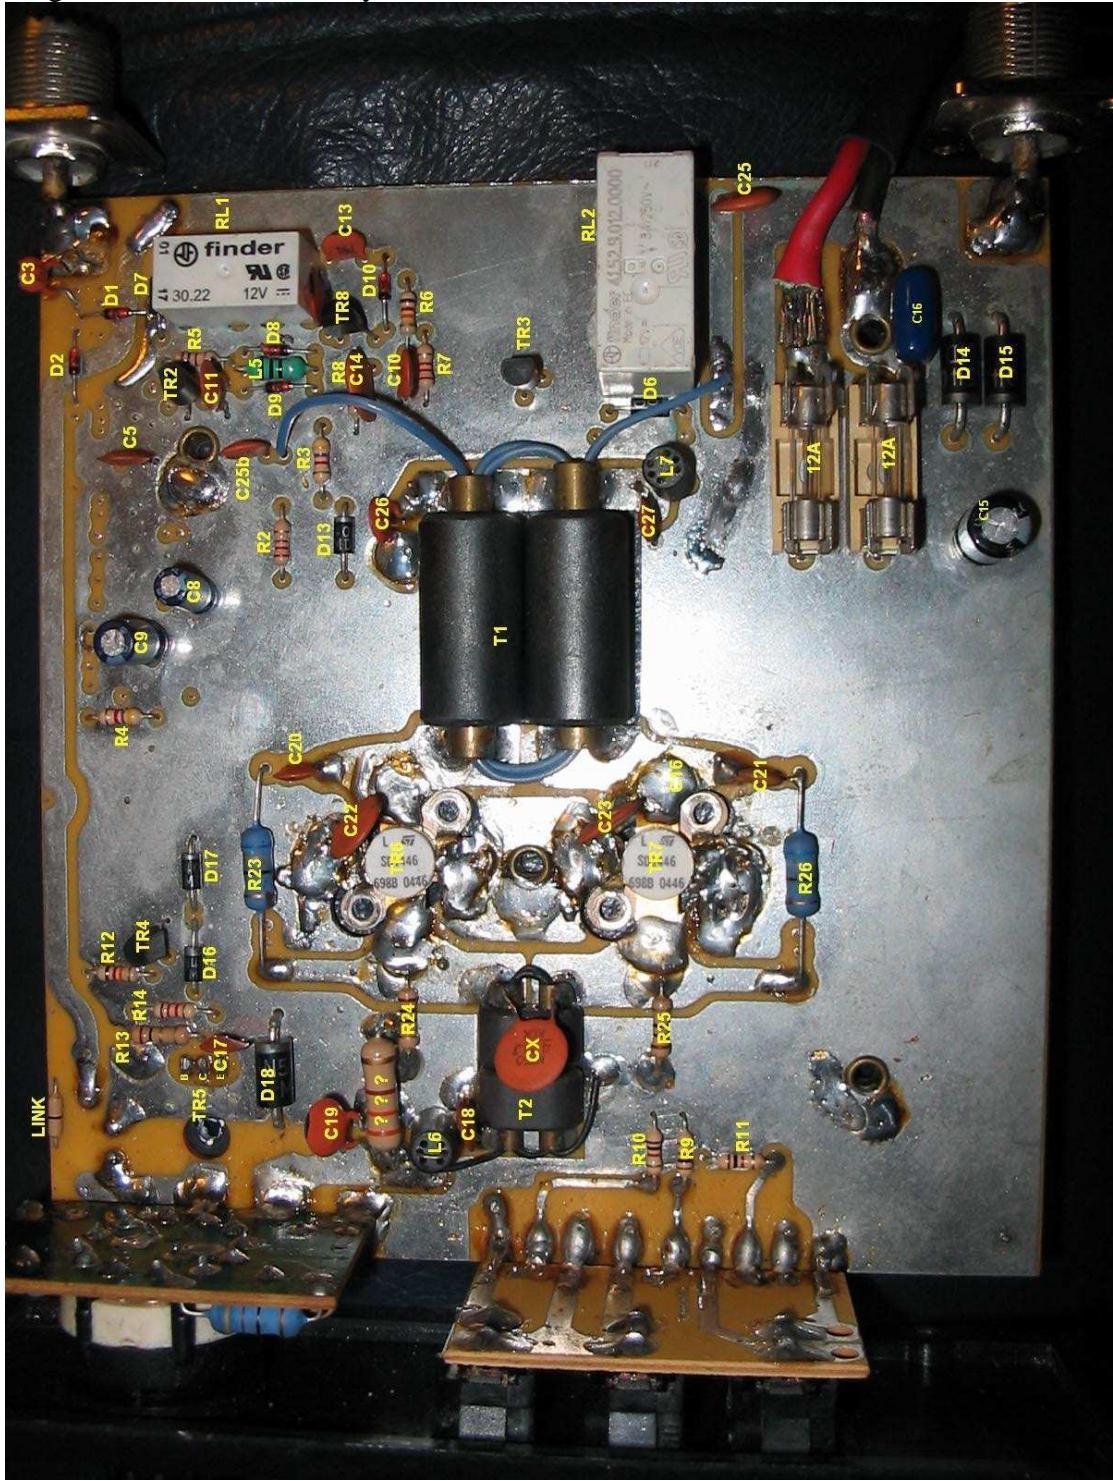
Note how the resistors R15 and R16 have been removed and the drive now goes directly into the power control board via a circuit pad underneath. This may have been done to cater for 4 Watt output UK rigs as the additional attenuation may have been intended to handle higher inputs, e.g. 10 Watts, from continental rigs. It is a puzzle why the 330 Ohm resistor has been added on the power control output pad. If you look closely to the left of C9 (middle of board – far left) you will see the wire link that connects TR1 and TR3 to a common single RF sensor.

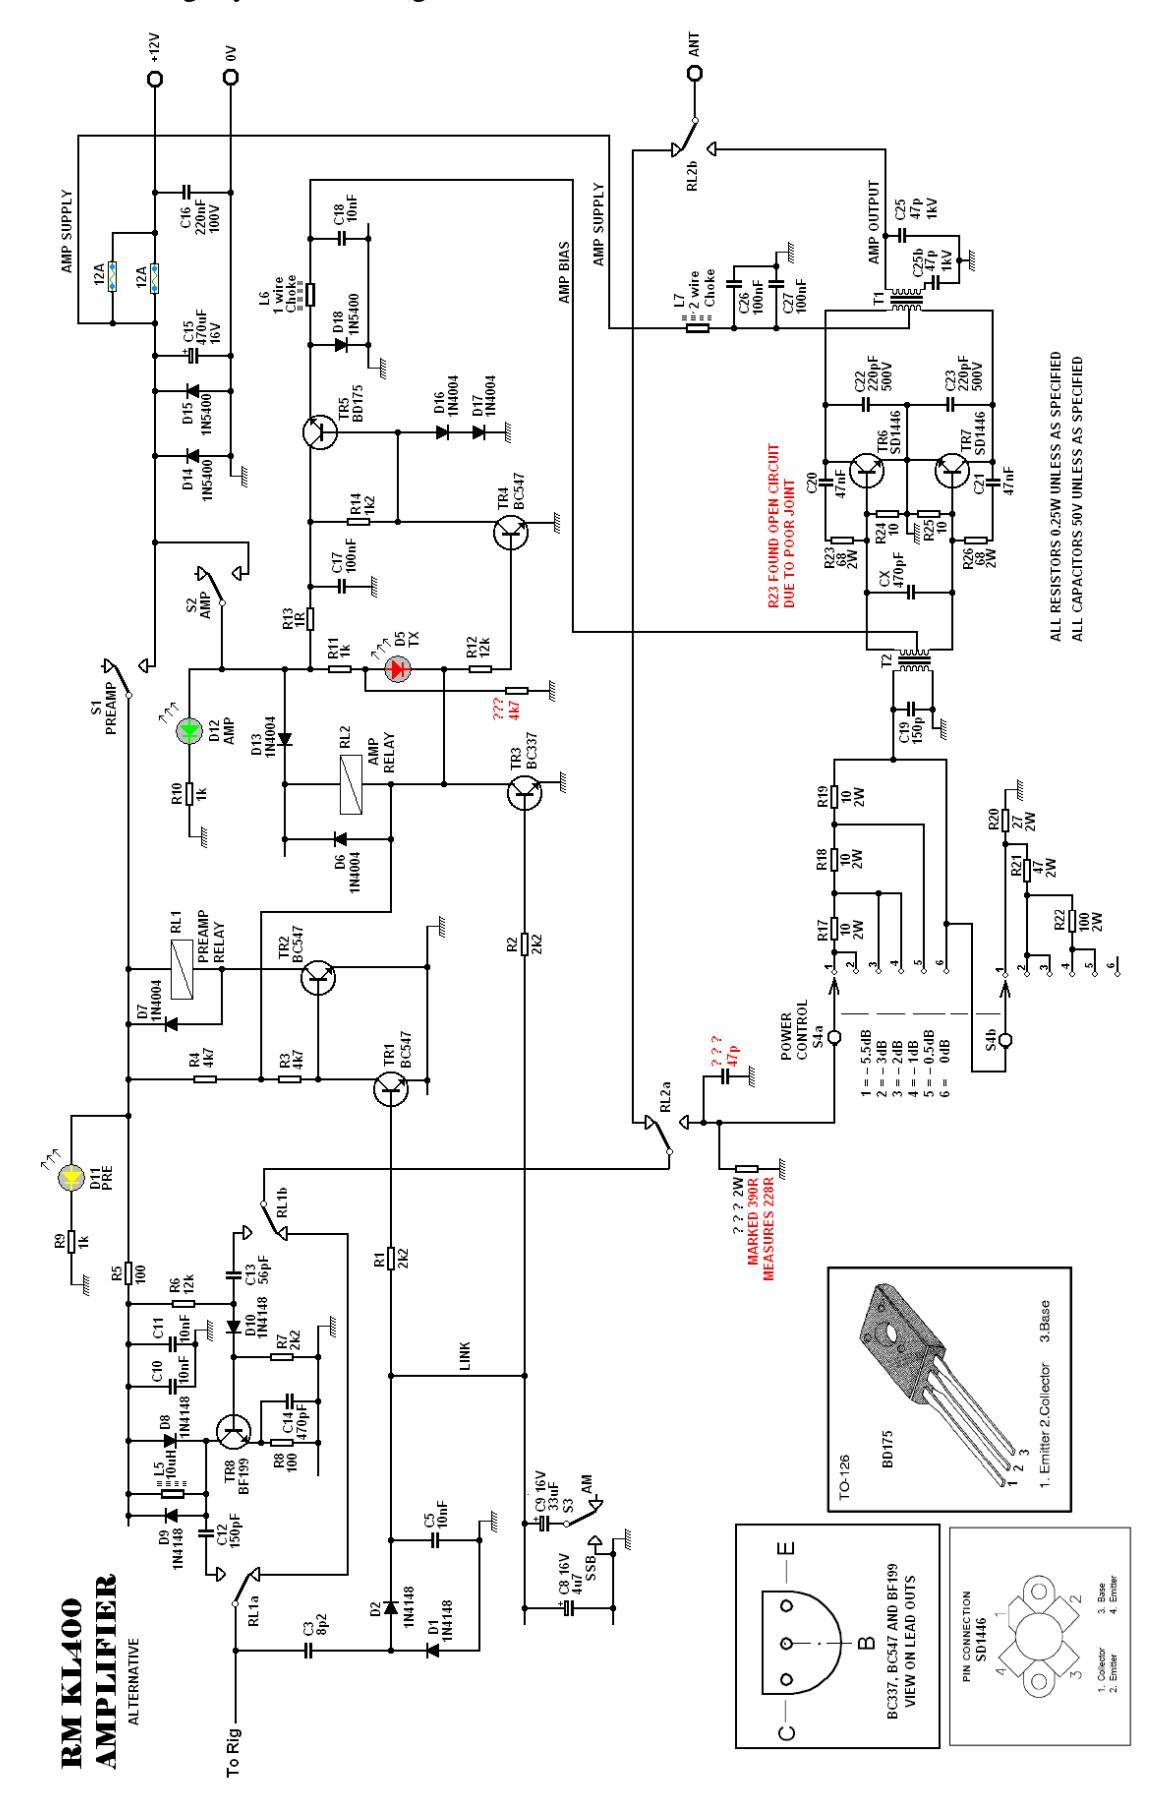
Another slightly different single sensor model – circuit

It is possible that the 4k7 resistor shown lower right hand side which connects with R11 was added to stop the dim glow of the TX LED when the AMP switch is set to ON and the driving rig is not keyed up. Note also that R15 and R16 have also been removed so the drive goes directly into the power control board. However it is the input pad this time that has a 390 Ohm resistor and 47pF capacitor added.

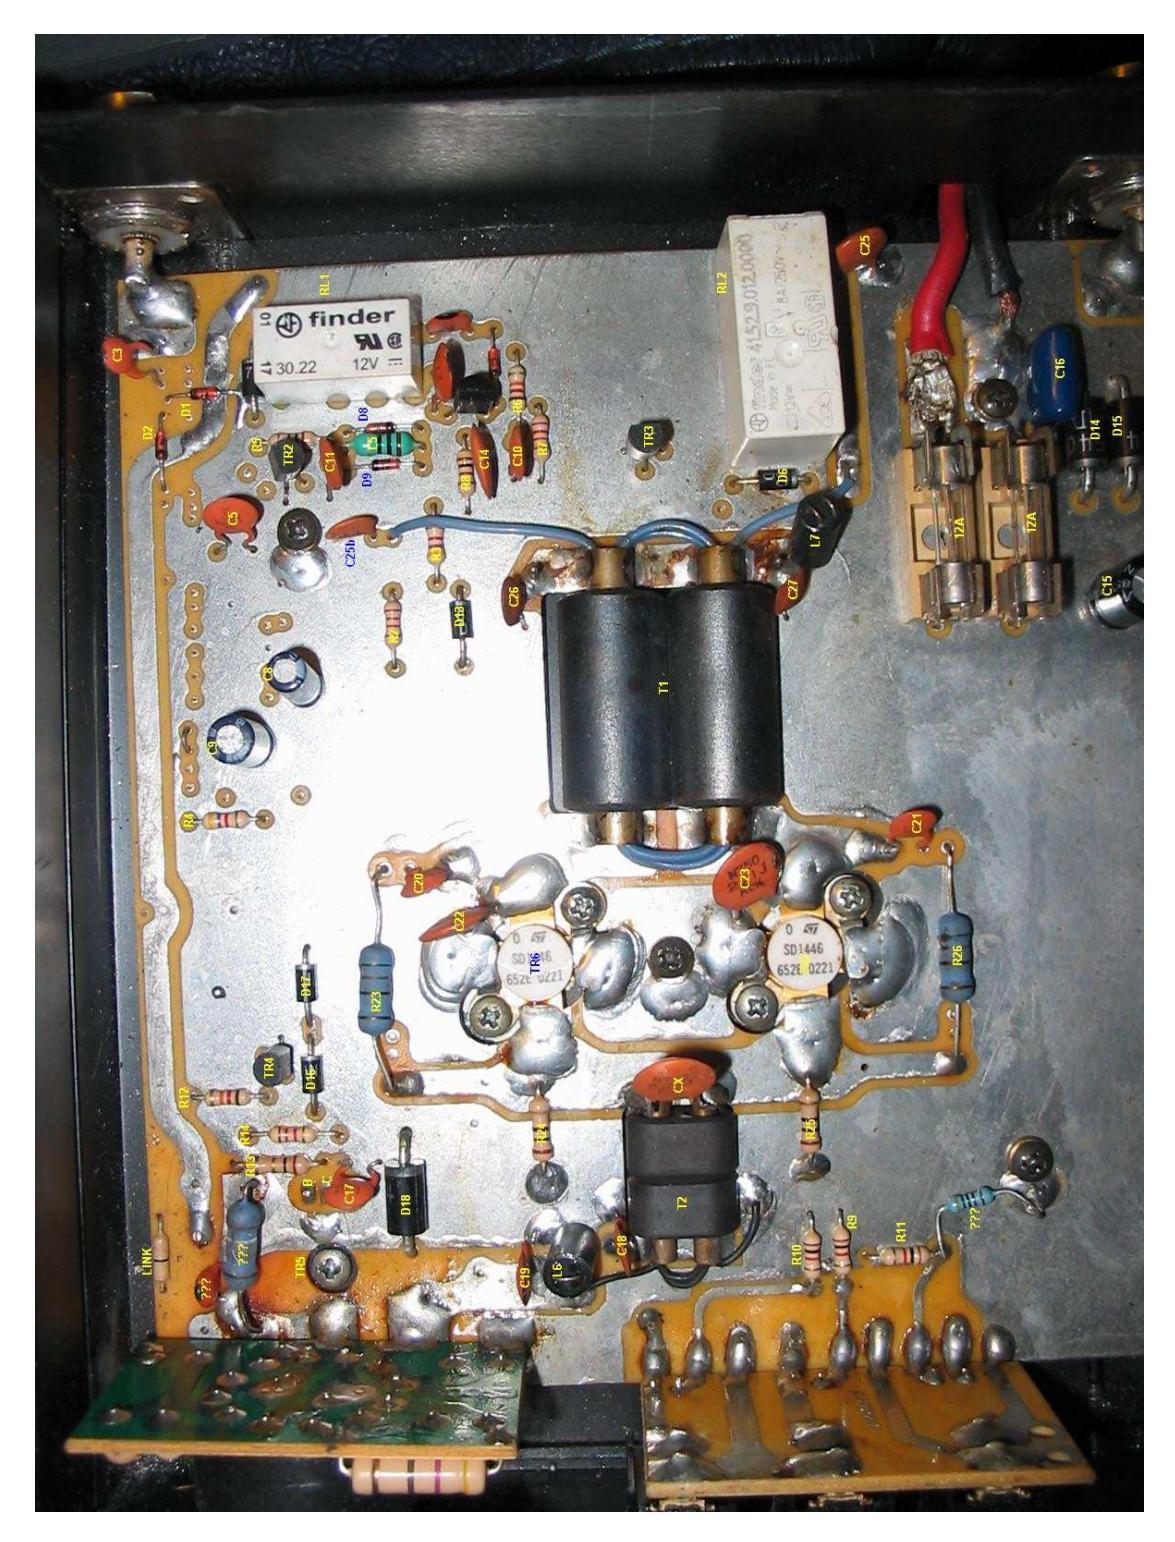
Another slightly different single sensor model – layout
